TIPPERARY COUNTY COUNCIL

TEMPLEMORE INFILL WORKS

STAGE 1 ROAD SAFETY AUDIT

Document Control Sheet	
Document Reference	11007 TR01 RSA
Report Status	ISSUE
Report Date	January 2022
Current Revision	D01
Client:	Tipperary County Council
Client Address:	Tipperary County Council Civic Offices Emmet Street, Clonmel Co. Tipperary
Project Number	11007

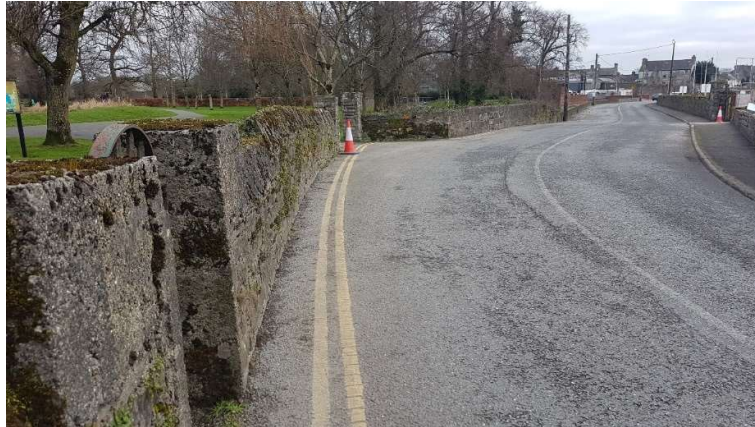
Figure 2-1 Road Markings and Alignment along the Blackcastle Road at the Town Park Entrance

Guiding of Existing Road Markings

At the northern end of the scheme along the Blackcastle Road, the existing edge of carriageway road markings do not guide vehicles in the same alignment as the road centreline. The edge of carriageway road marking follows the existing boundary wall line. This may lead to vehicles being guiding into pedestrians or the culvert wall especially at times of low visibility (i.e. fog).

Recommendation

The Design Team should provide appropriate delineation measures / boundary treatment measures and warning of the hazard.

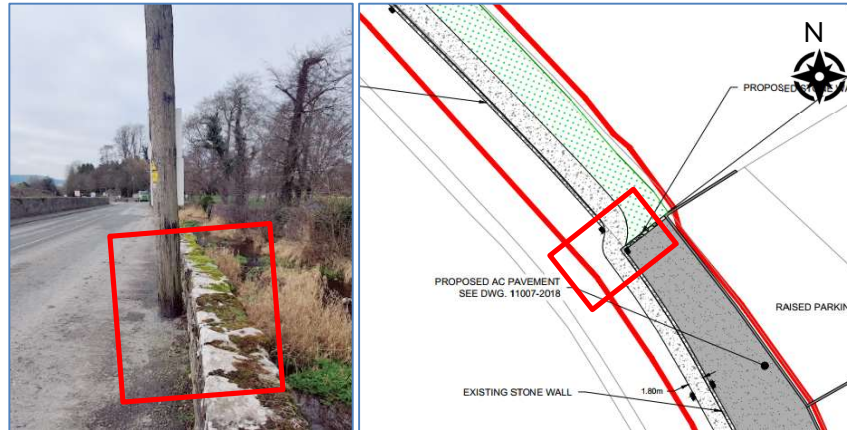
Figure 2-3 Drawing 11007-2014-D01 extract showing interface between road and proposed footway

Interface between Pedestrian Footway and Road Carriageway

The footway alignment shifts from behind the culvert wall to online into the existing carriageway (i.e. abrupt change in alignment). The development of the footway occurs instantaneously in line of oncoming traffic without any proposed protection. Wall height may pose an issue to the visibility of small children while the sudden inclusion of a kerb without prior

warning could present a significant safety hazard to drivers leading to both pedestrian and vehicular collisions.

Recommendation

The Design Team should create a safe means of access to pedestrians to move from behind the wall to the front of the wall, with adequate warning and safety provisions for both motorised and non-motorised users.

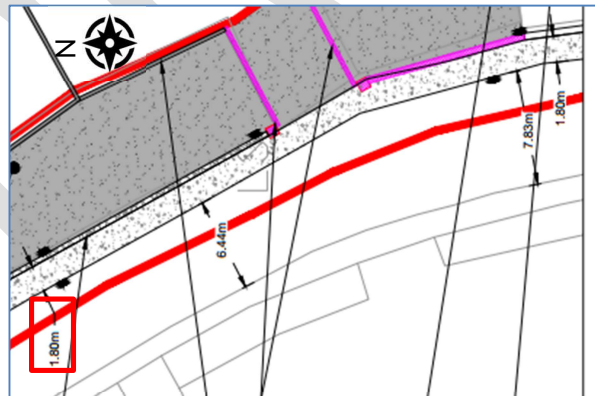
Figure 2-4 Extract of Proposed Footway widths from preliminary design drawings

Proposed Footway Widths

The audit team note that the proposed width is in line with the absolute minimum standard footway widths, potentially creating a passing hazard for pedestrians forcing them onto the existing carriageway creating a conflict point between vehicles and pedestrians, in particular for wheelchair users and those pushing buggies / prams.

Recommendation

The Design Team should ensure the footway width is adequate for passing pedestrian movements demands.

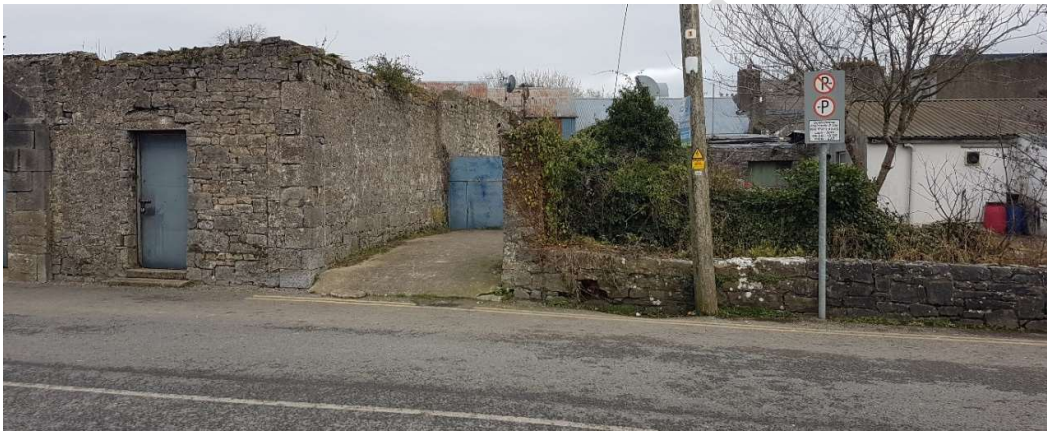
Figure 2-5 Currently Parking allowances along the Blackcastle Road just North of the N62 junction

On street Parking

Along Blackcastle Road, parking is currently permitted commencing a distance of approximately 30m north of the junction with the N62 towards the park pedestrian entrance. The auditors note that if the existing parking provision is maintained upon construction of the new footway, it will result in vehicles parked within the carriageway reducing the road width. Resulting in obstructions to two-way passing vehicular movements with unsuitable visibility to allow yielding. This may result in head on collisions and driver frustration resulting in unsafe road behaviour.

Recommendation

The Design Team should provide appropriate parking signage in coordination with the proposed design.

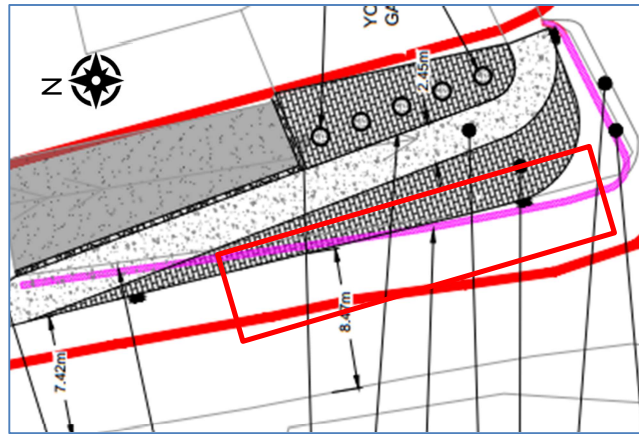
Figure 2-6 Proposed Streetscape Design at the Junction of the N62 and Blackcastle Road

On street Parking - Streetscape Parking

A streetscape area is proposed at the junction of the N62 with the Blackcastle Road within the infilled lands. The Audit Team are concerned the wide streetscape area may give rise to vehicles parking on it. This may result in potential conflicts with pedestrian and vehicles and also give rise to junction visibility issues leading to potential collisions at the junction.

Recommendation

The Design Team should provide appropriate measures to prevent vehicles parking on the paved area within the proposed design.

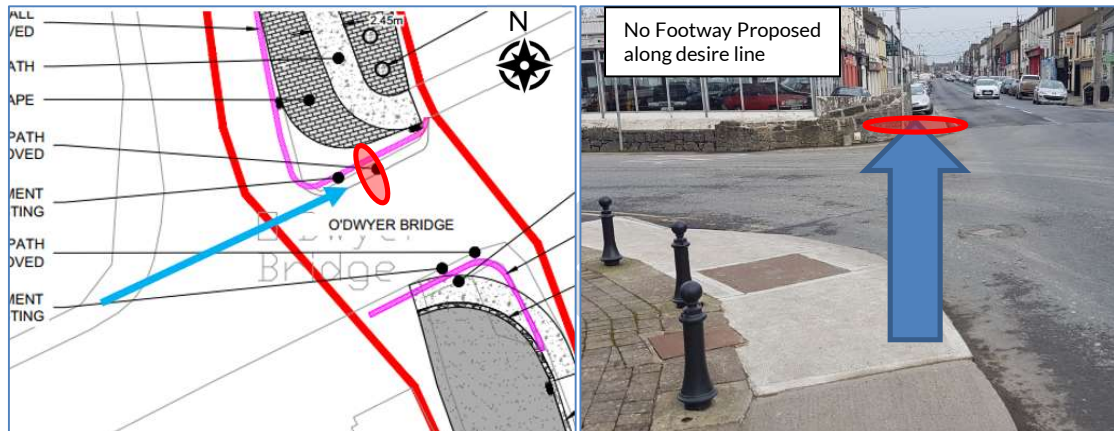
Figure 2-7 Existing Pedestrian Desire Lines across Blackcastle Road

Pedestrian Desire Lines

At the streetscape area at the junction of Blackcastle Road and the N62, the roadway at O'Dwyer's Bridge is proposed to be widened and the footway set back behind the existing parapet line. The Audit Team are concerned this will affect the pedestrian desire lines crossing Blackcastle Road. In particular, the existing infrastructure (i.e. drop kerbs) on the left hand side of the junction will guide visually impaired VRUs into the road carriageway, potentially leading pedestrians stranded in the carriageway and collisions between motorised and pedestrians.

Recommendation

The Design Team should review the pedestrian desire line based on the proposed design and ensure the design ties into the existing road infrastructure. Provisions for visually impaired road users should be provided in the design (i.e. tactile paving at road crossing).

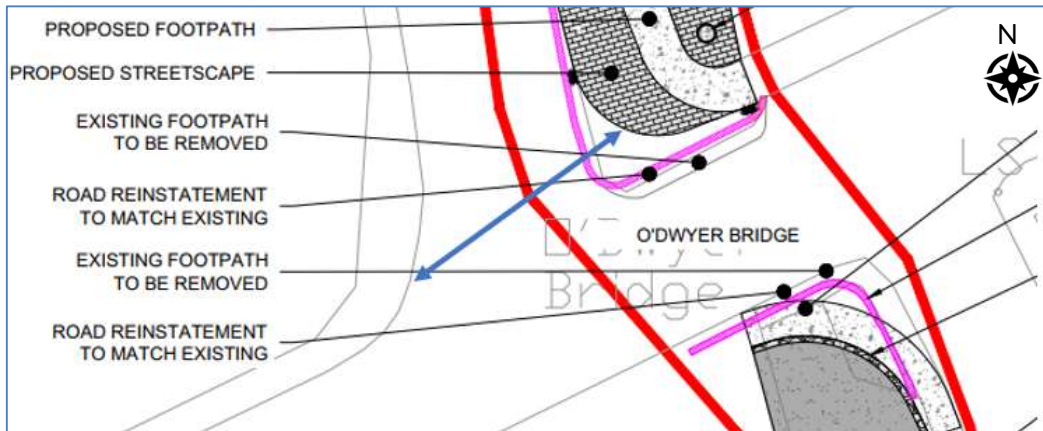
Figure 2-8 Proposed N62 / Blackcastle Road Junction Width

Width of Proposed Junction – N62 / Blackcastle Road

The proposed design shows work only to the eastern side of the N62 / Blackcastle Road junction. The existing wide corner radius on the west side of the junction, in conjunction with the increased eastern corner radius will potentially give rise to higher vehicle speeds turning at the junction. It will also result in increased pedestrian crossing times, which will increasing the risk of collisions between motorised and non-motorised road users.

Recommendation

The Design Team should provide junction widths in accordance with guidance from the Design Manual for Urban Roads and Streets in accordance with the urban road speed.

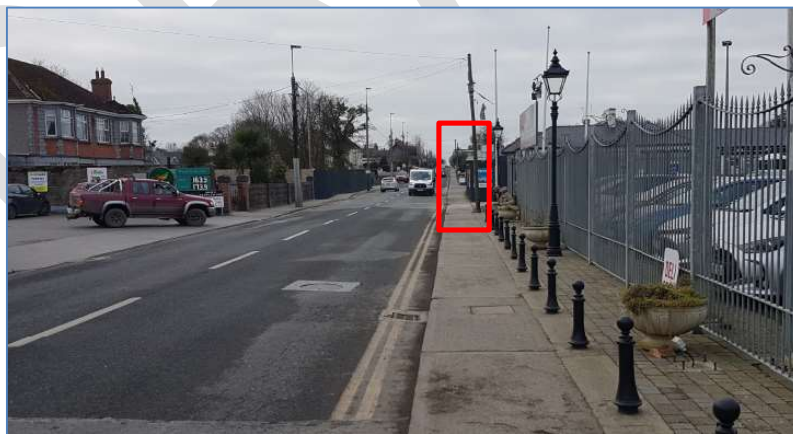
Figure 2-9 Eastbound Approach to the N62 / Blackcastle Road / The Mall Junction

Junction Warning Signage

The Audit team observed onsite the presence of warning signage on the minor road approaches to the N62 staggered junction. Warning signage is being provided on the major road approaches in both directions at quite a distance away from the junction. Significant distance of warning signage to hazards may result in lack of awareness of drivers, believing the warning signs are no longer valid to the area. This could give rise to head on collisions, turning collisions or rear end collisions at the junction as drivers may.

Recommendation

The Design Team should provide staggered junction warning signage on the major road at suitable distances from the hazard.

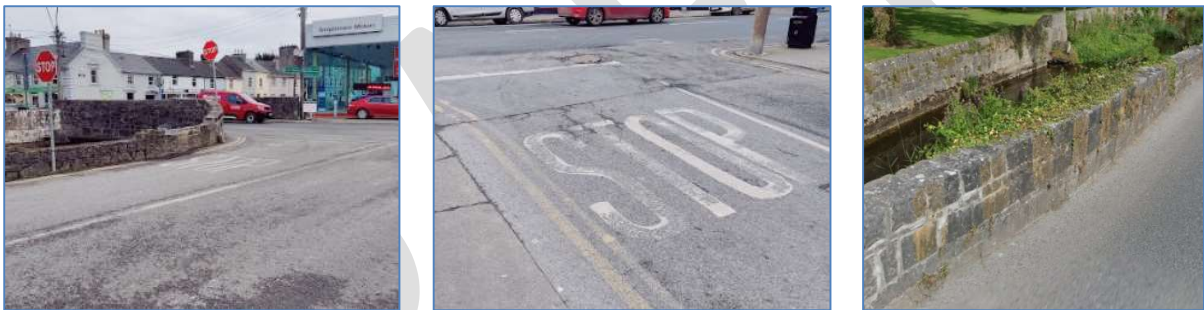
Figure 2-10 Faded Road Markings at the N62 / Blackcastle Road / The Mall Junction and Blackcastle Road

Faded Line Markings

The Audit team observed onsite that the existing road markings within the scheme, in particular, at the N62 / Blackcastle Road / The Mall junction and on the approaches to the junction are heavily worn. The faded line markings could lead to drivers unable to accurately determine the road layout and result in collisions with other road users.

Recommendation

Road Markings in and around the scheme should be reinstated to improve safety.

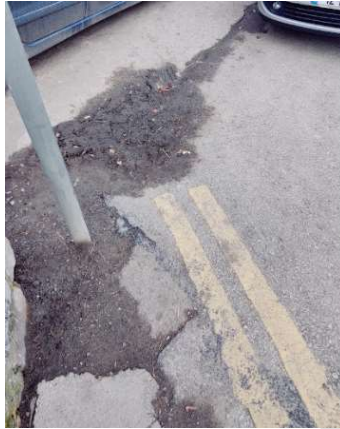
Figure 2-11 Area of Water Ponding on the East of the N62 / Blackcastle Road Junction

Drainage Issues

The Audit team noted that in the vicinity of the N62 / Blackcastle Road / The Mall junction that areas of potential water ponding were observed onsite. Ponding water could lead to slip hazards for pedestrians or force pedestrians off footways and into the carriageway creating conflict points between motorised and non-motorised road users.

Recommendation

The Design Team should provide adequate drainage.

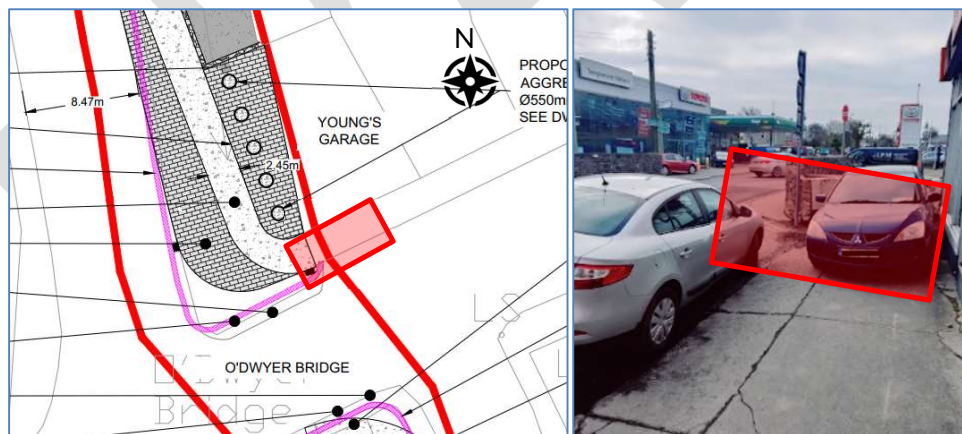
Figure 2-12 Interface of proposed footway and existing footway alignment

Parked Cars and Pedestrian Facilities

The Audit Team observed parking to the east of the N62 / Blackcastle Road junction fronting Young’s Garage. The proposed footway alignment tying into the existing footway, may overlap with this area, displacing vehicles resulting in vehicles parked in closer proximity to the junction negatively impacting on visibility. Or vehicles parked on the proposed footway impeding pedestrians.

Recommendation

The Design Team should ensure adequate visibility is provided at the junction clear of parked vehicles.

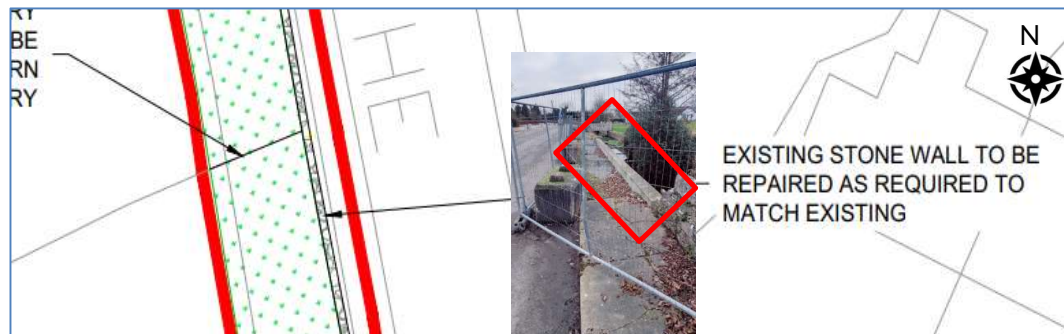
Figure 2-13 Existing Stone Wall and Footpath provision and Proposed Works

Footway and Pedestrian Restraints

The Audit Team observed along The Mall Road, the existing footway and culvert wall has been significantly damaged with proposed design noting that *“the existing stone wall to be repaired as required to match existing”*. Retention of the existing footway in the current state is a significant trip hazard to pedestrians.

Recommendation

The footway at this location should be reinstated in combination with the wall repairs.

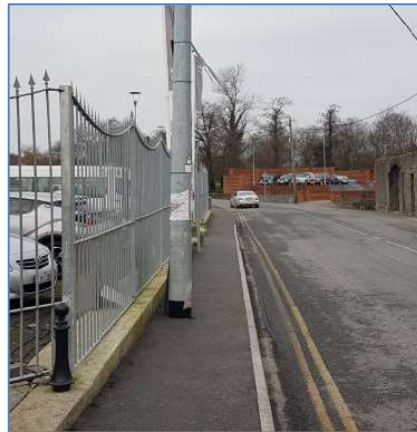
Figure 3-1 Restricted Footway Width on Blackcastle Road adjacent to scheme

Restricted Footpath Widths Adjacent to Proposed Works

The Road Safety Audit Team noted during the site visit that adjacent to the scheme are areas of restricted footpath widths due to temporary and permanent fixtures.

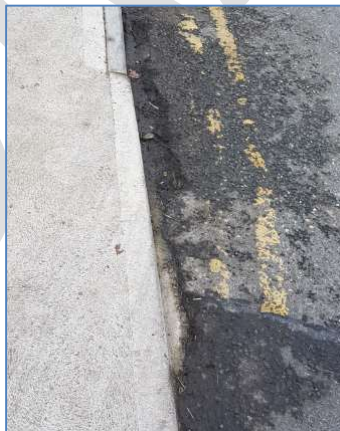
Figure 3-2 Trip hazards at drop kerb locations

Trip Hazards at Drop Kerbs

The Road Safety Audit Team noted during the site visit that adjacent to the scheme drop kerbs which exceed the allowable specification tolerances and deterioration of the road pavement are creating trip hazards for pedestrians.

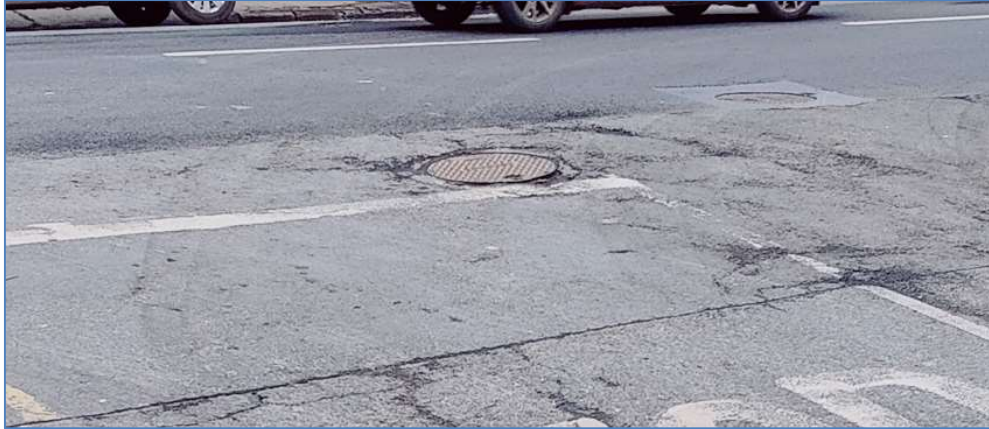
Figure 3-3 Pavement Deterioration at Utility Covers

Trip Hazards & Pavement Deterioration at Utility Covers

The Road Safety Audit Team observed during the site visit that pavement deterioration was occurring at some utility covers potentially creating an issue for vehicles and trip hazard for pedestrians.

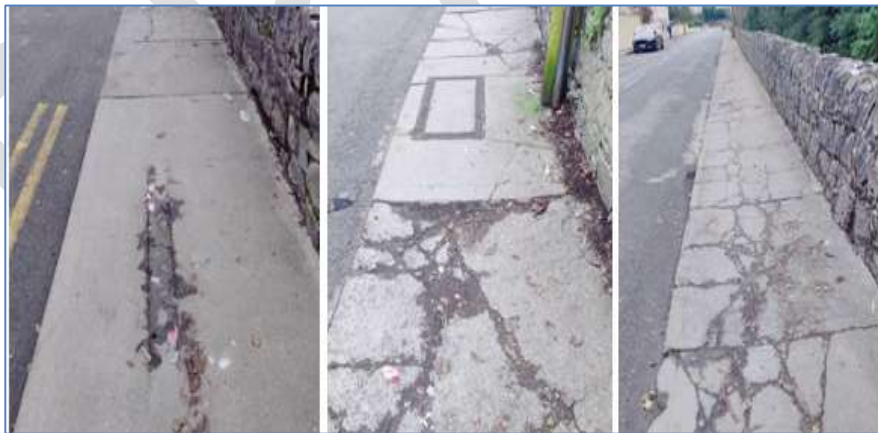
Figure 3-4 Examples of Footway Deterioration adjacent to proposed works

Footway Conditions

The Road Safety Audit Team observed during the site visit, significant pavement deterioration on the River Mall Road creating a significant safety and trip hazards for pedestrians.

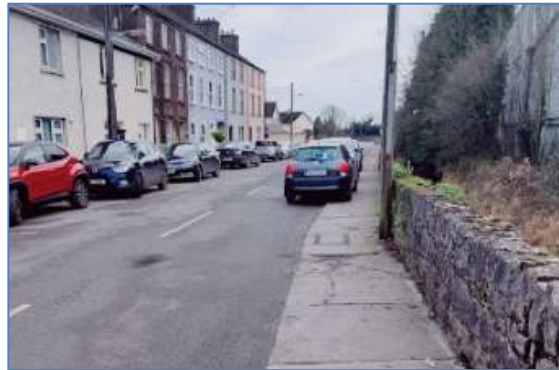
Figure 3-5 Blocked Footways by parked vehicles

Parking on Footways

The Audit Team observed along The Mall Road, parking is allowed on both sides of the carriageway. On the footway adjacent to the northbound lane, existing low kerb heights are facilitating vehicles parking and blocking footways which may force VRUs (i.e. wheelchairs and pedestrians with buggies) into the carriageway. Significant footway deterioration was also

observed along this side of the carriageway, which coincides with the position of parked vehicles.

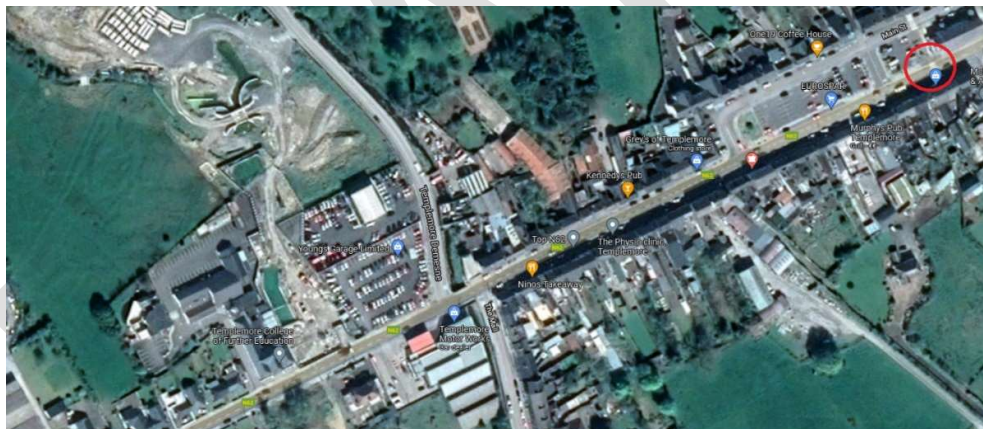
Figure 3-6 Location of Nearest Pedestrian Crossing to the Staggered Junction

Pedestrian Crossing Facilities

The Road Safety Audit Team noted during the site visit that there is limited provision for pedestrian crossing facilities on the N62. The closest pedestrian crossing facility is located approximately 300m east of the Blackcastle Road / N62 / The Mall staggered junction.
