Part 8 Application for Nenagh Historical and Cultural Quarter

Structural Condition Report on Barbican Walls and Proposed New Entrance to Nenagh Castle

204199-PUNCH-XX-XX-RP-S-001

November 2023

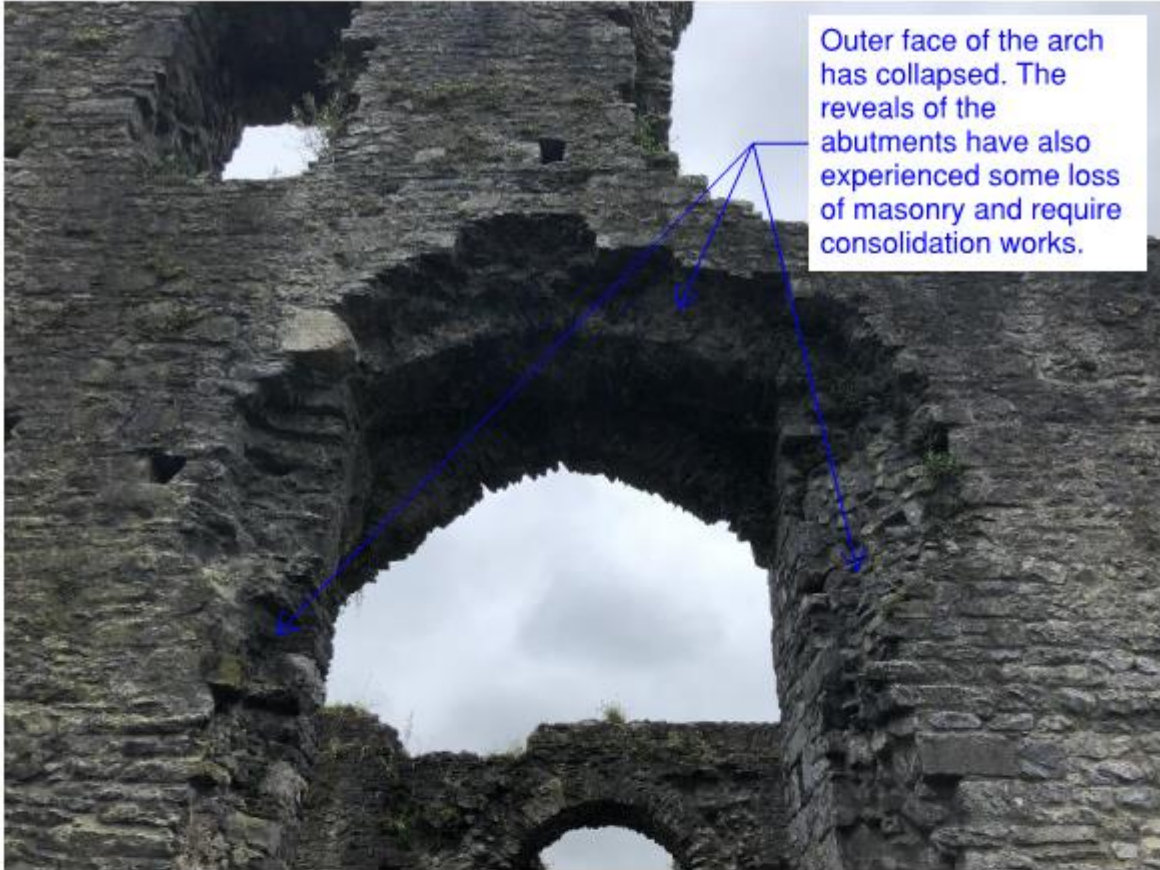
Image 3

Outer face of the arch has collapsed. The reveals of the abutments have also experienced some loss of masonry and require consolidation works.

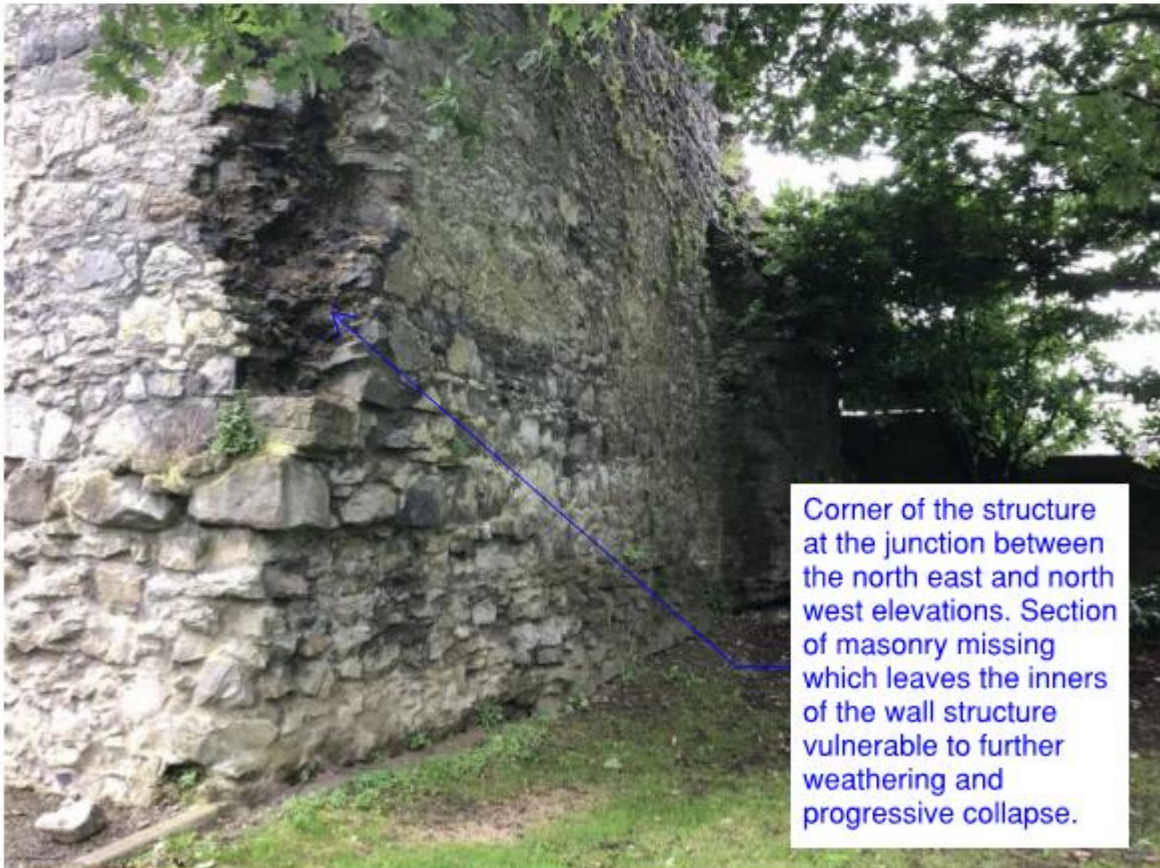
Image 4

Corner of the structure at the junction between the north east and north west elevations. Section of masonry missing which leaves the inners of the wall structure vulnerable to further weathering and progressive collapse.

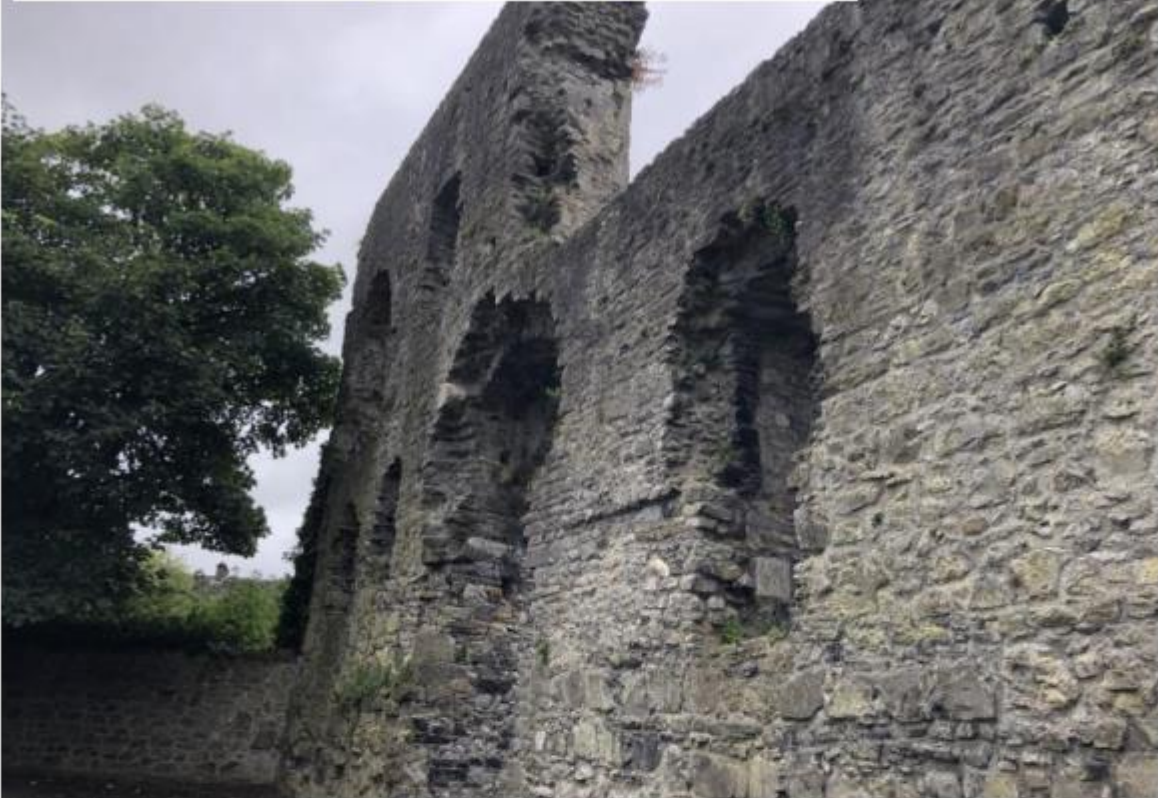
Image 7

Record photo with the Barbican walls looking in a south easterly direction. Original wall to this side of the barbican is no longer present.

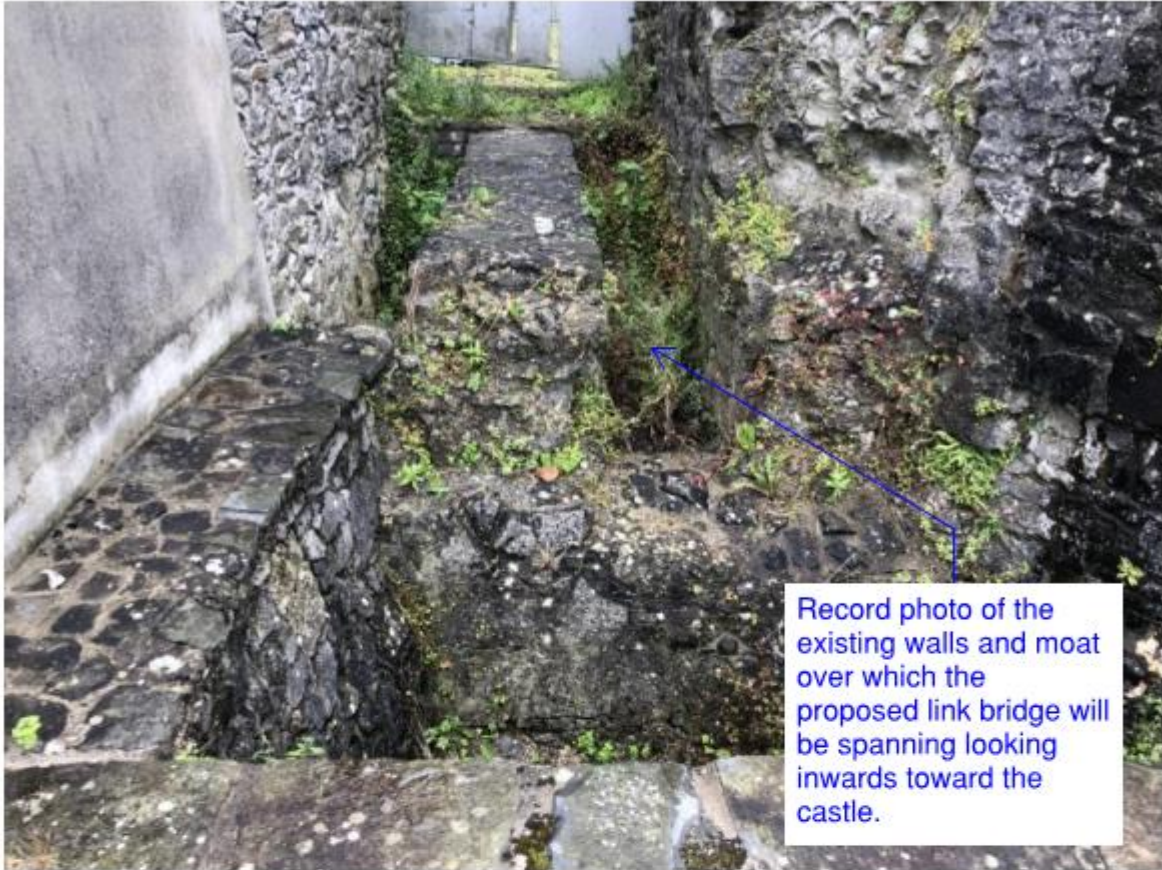
Image 19

Record photo of the existing walls and moat over which the proposed link bridge will be spanning looking inwards toward the castle.

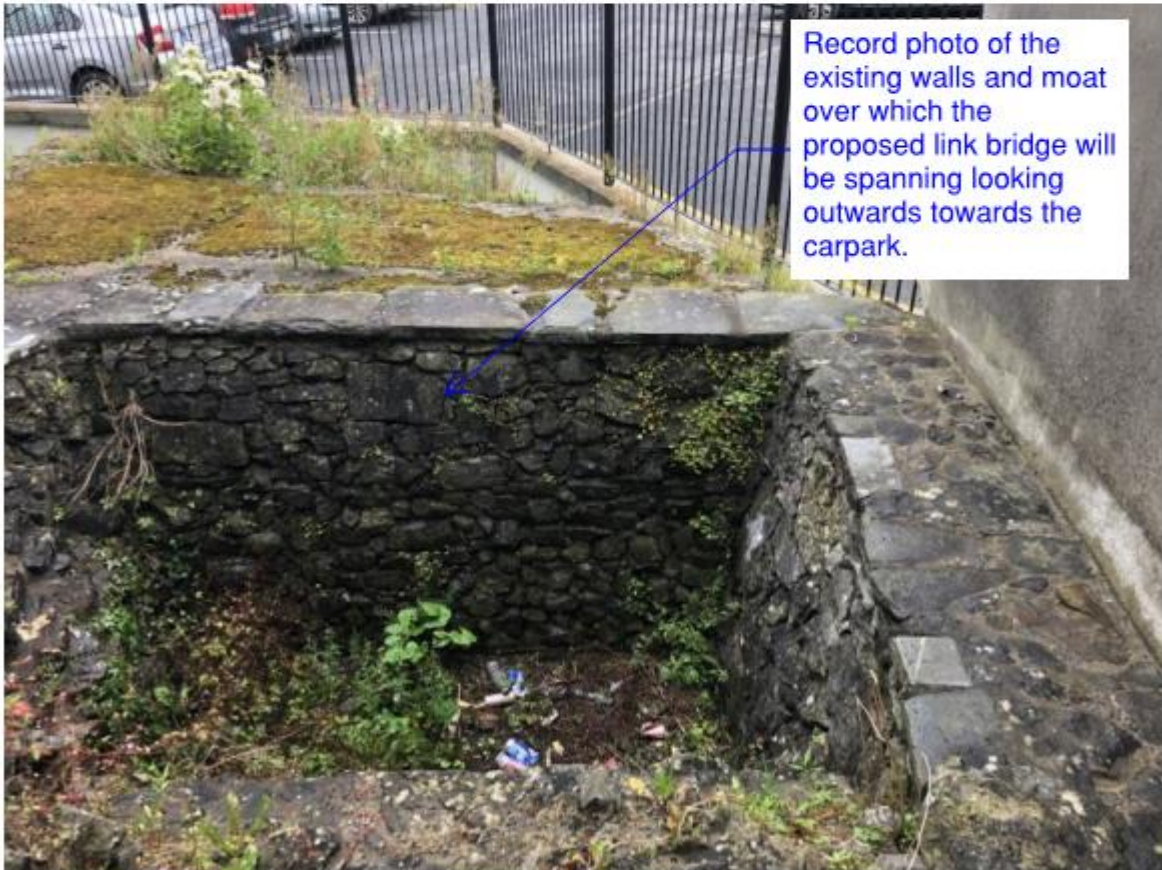
Image 20

Record photo of the existing walls and moat over which the proposed link bridge will be spanning looking outwards towards the carpark.
