# TIPPERARY TOWN HISTORICAL LANDFILL REMEDIATION

## APPROPRIATE ASSESSMENT SCREENING REPORT AND NATURA IMPACT STATEMENT FOR TIPPERARY TOWN HISTORICAL LANDFILL REMEDIATION

**Abstract:** This document comprises the Stage One: Appropriate Assessment Screening Report and Natura Impact Statement for the Historic Landfill at Carrownreddy, Tipperary Town. Appropriate Assessment is required under Article 6 (3) of the Habitats Directive for any project or plan that may give rise to significant effects on a European (Natura 2000) site.

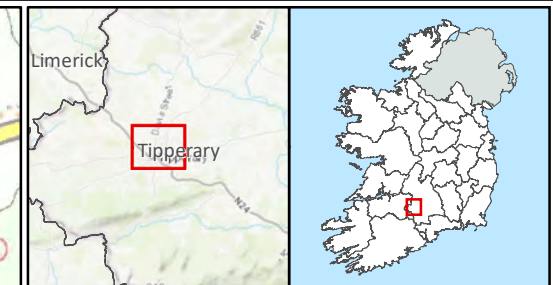
<b>TITLE:</b>	Site Location
<b>PROJECT:</b>	Tipperary Town Historical Landfill Remediation
<b>FIGURE NO:</b>	1.1
<b>CLIENT:</b>	Tipperary County Council
<b>SCALE:</b>	1:15000
<b>REVISION:</b>	0
<b>DATE:</b>	09/11/2022
<b>PAGE SIZE:</b>	A3

— Landfill Boundary

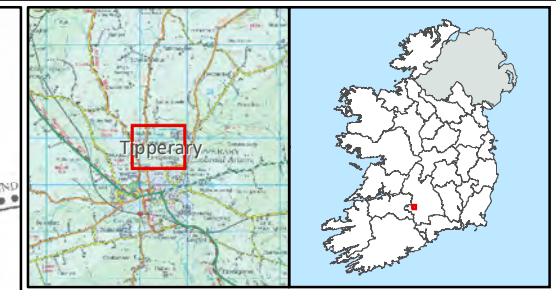
<b>TITLE:</b>	Habitats
<b>PROJECT:</b>	Tipperary Town Historical Landfill Remediation
<b>FIGURE NO:</b>	3.1
<b>CLIENT:</b>	Tipperary County Council
<b>SCALE:</b>	1:3500
<b>REVISION:</b>	0
<b>DATE:</b>	19/10/2020
<b>PAGE SIZE:</b>	A3

- Landfill Boundary
- Indicative Footprint of Remedial Works
- Habitat Classification**
- FW2: Depositing/Lowland Rivers
- BL1: Stone walls and other stonework
- WL1/WL2: Hedgerows / Treelines
- FW4: Drainage Ditches
- BL3: Buildings and Artificial
- ED2/ED3/WS1: Spoil and Bare Ground / Recolonising Bare Ground / Scrub
- ED2/ED3: Spoil and Bare Ground / Recolonising Bare Ground
- ED2: Spoil and Bare Ground
- ED3/WS1: Recolonising Bare Ground / Scrub
- ED3: Recolonising Bare Ground
- ED5: Refuse and Other Waste
- FS1: Reed and Large Sedge Swamps
- GA1/ED3: Improved Agricultural Grassland / Recolonising Bare Ground
- GA1: Improved Agricultural
- GS2: Dry Meadows and Grassy Verges
- GS4: Wet Grassland
- WD1: (Mixed) Broadleaved Woodland
- WN6: Wet Willow-Alder-Ash Woodland
- WS1: Scrub

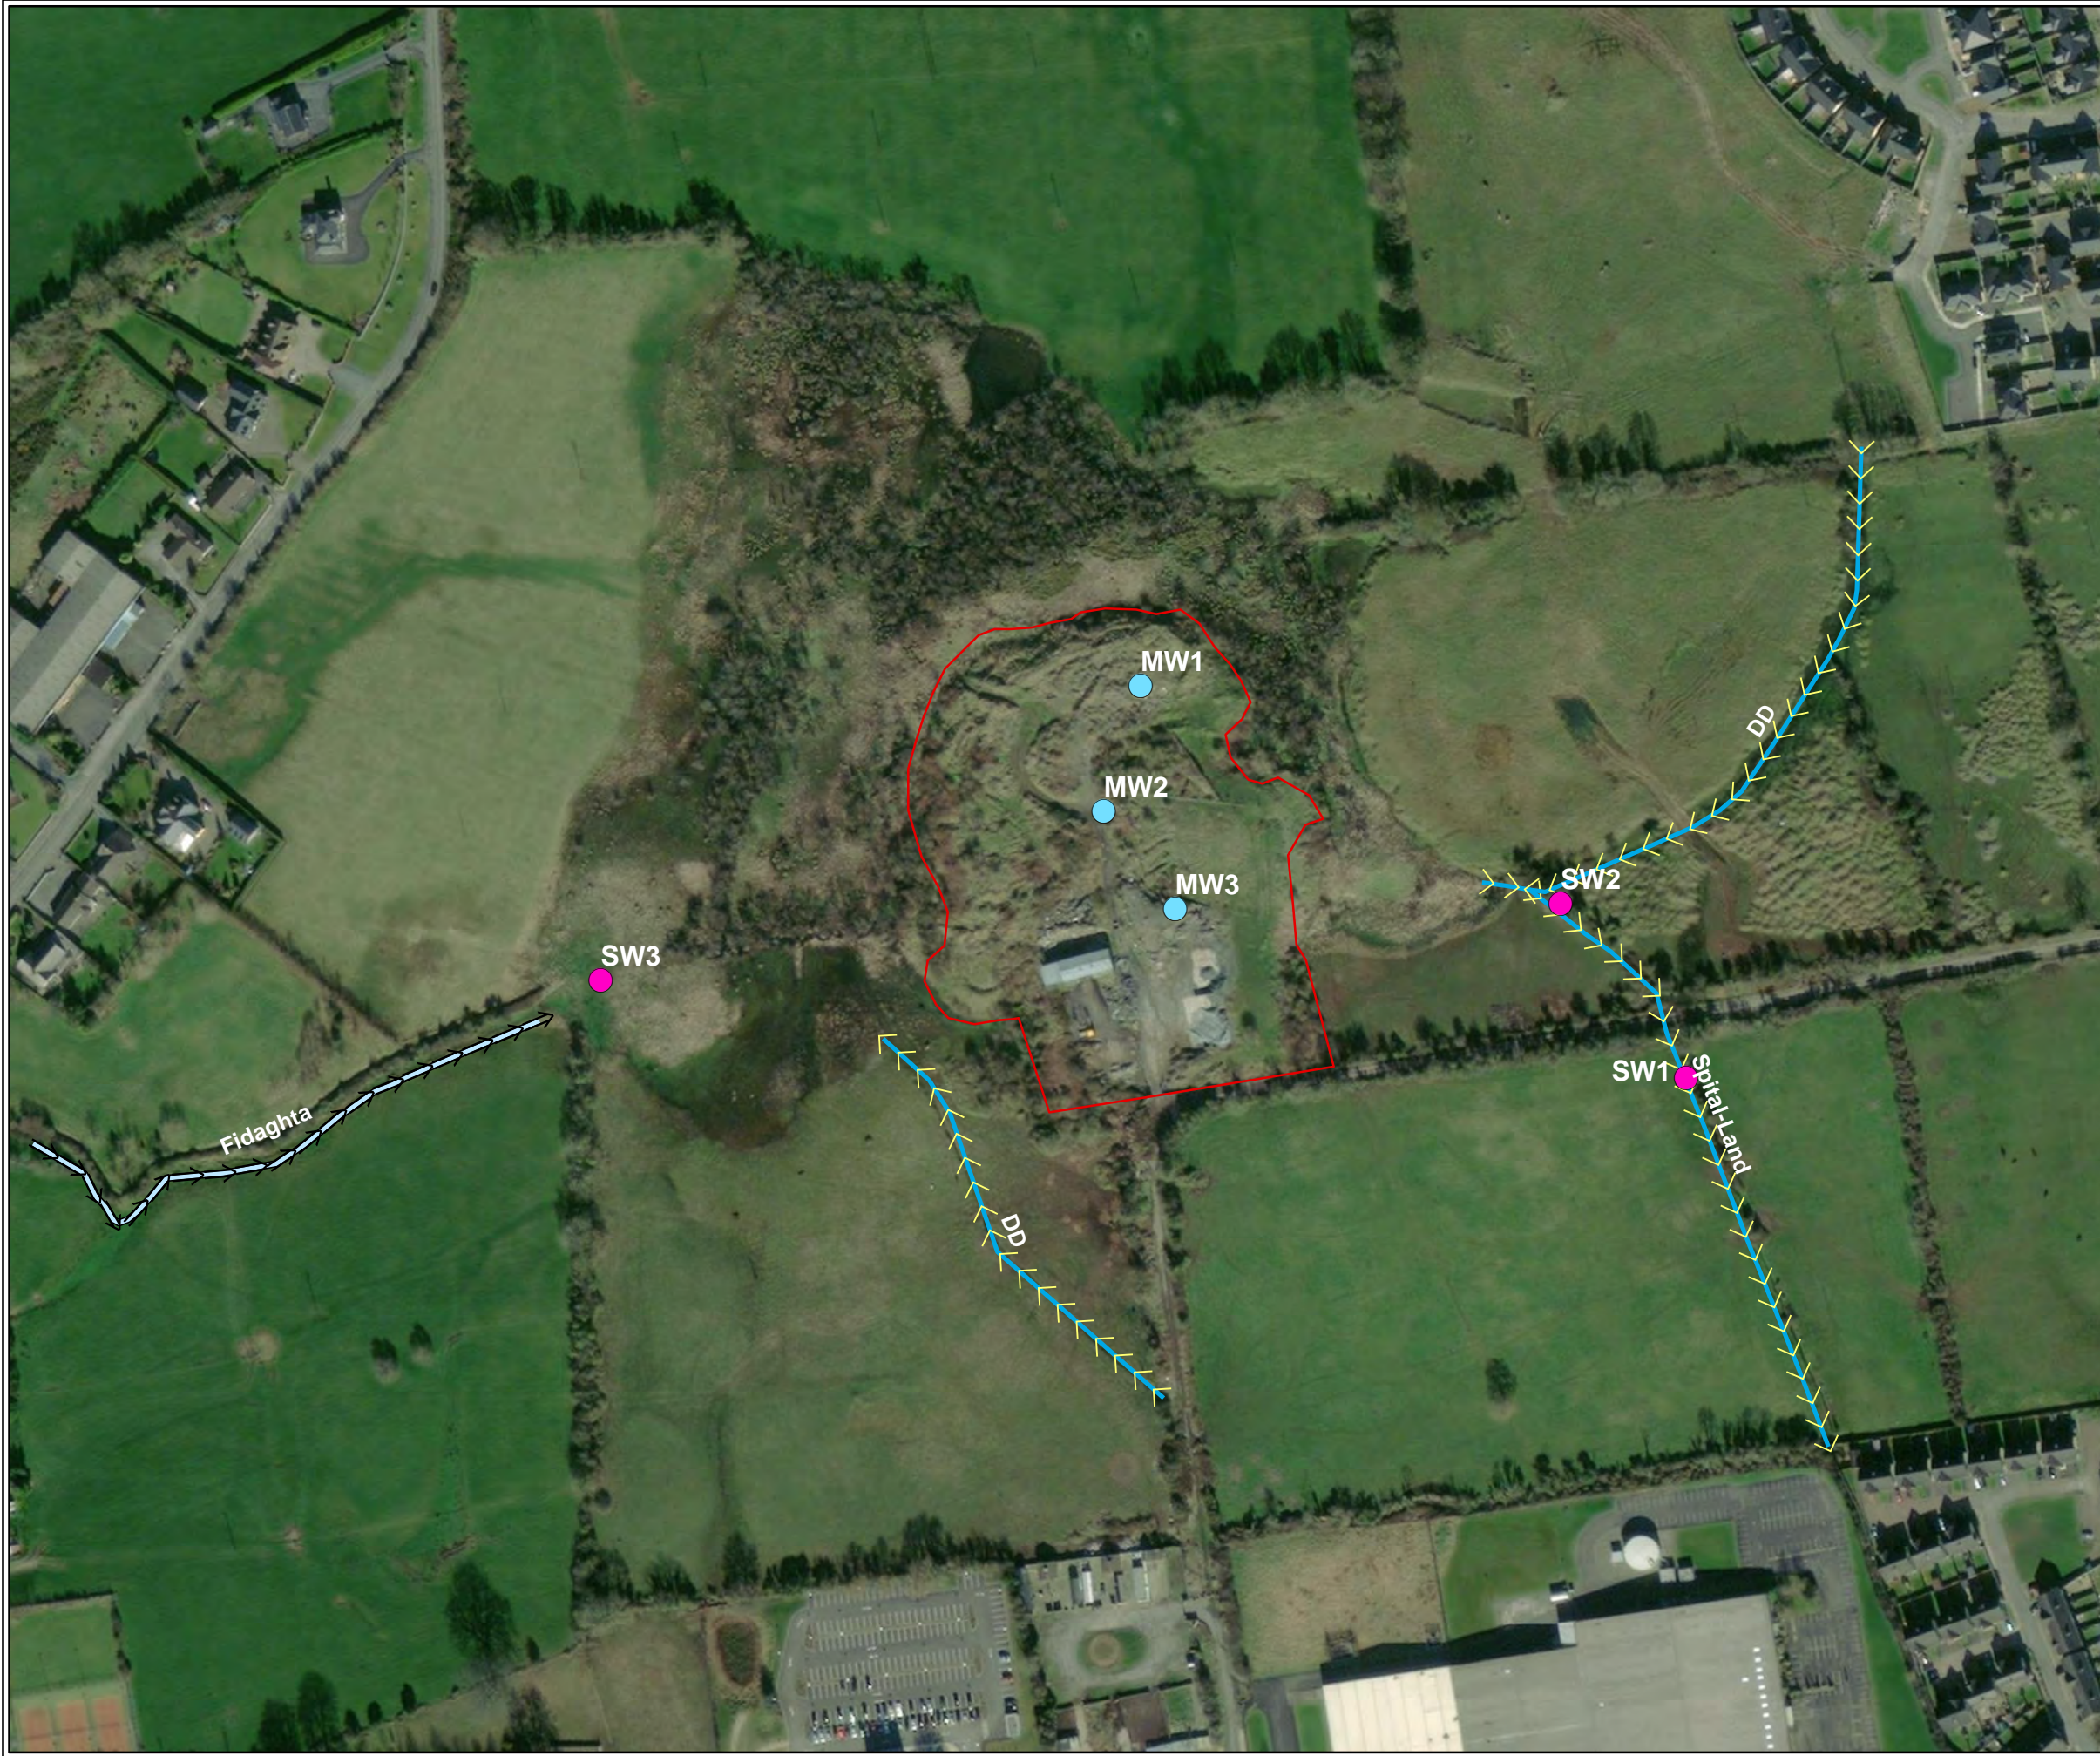
<b>TITLE:</b>	Surface Water and Leachate Sampling Points		
<b>PROJECT:</b>	Tipperary Town Historical Landfill Remediation		
<b>FIGURE NO.:</b>	3.2		
<b>CLIENT:</b>	Tipperary County Council		
<b>SCALE:</b>	1:2500	<b>REVISION:</b>	0
<b>DATE:</b>	19/10/2020	<b>PAGE SIZE:</b>	A3

-   Landfill Boundary
-   Leachate Sampling Points
-   Surface Water Sampling Points
-   Drainage Ditches
-   Depositing/Lowland Rivers

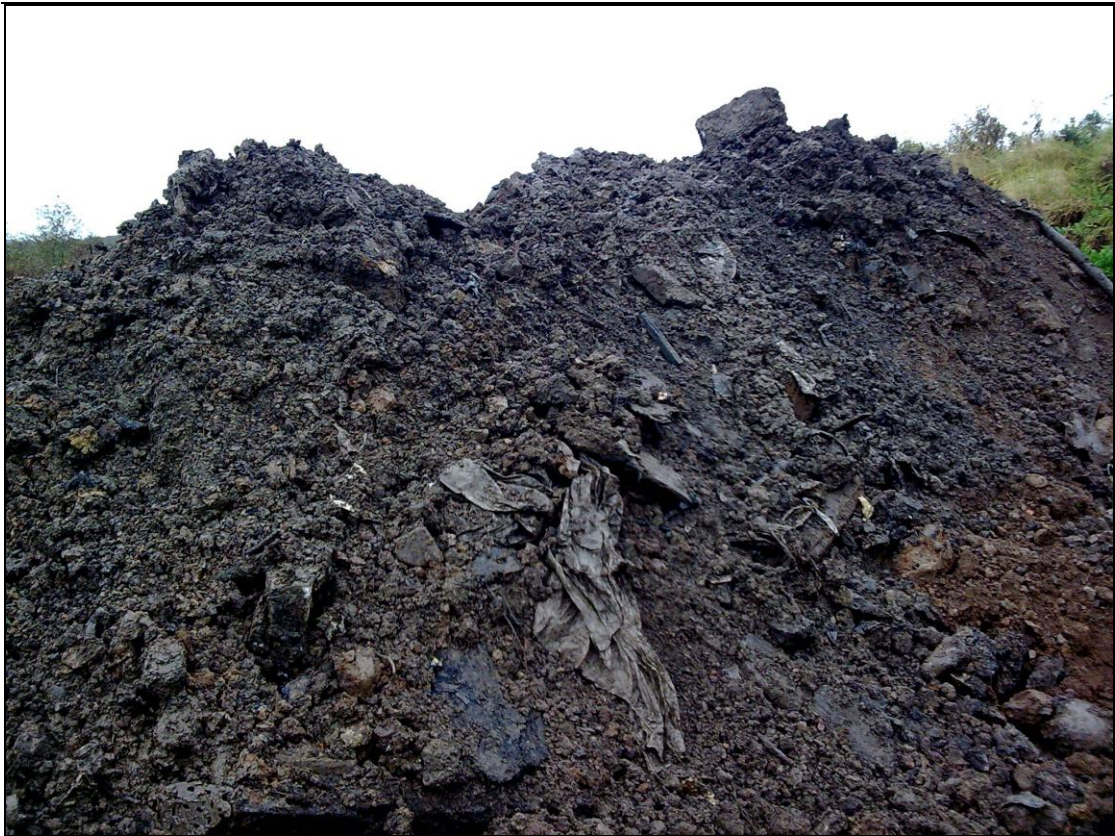
The area north of the on site building and road maintenance materials is covered in soils and stone mixed with minor amounts of what appears to be C&D waste. This material is on average 1.5m to 2.5m thick. This material appears to have been brought onto site after the facility officially closed and has not been graded

Photo 1 Waste in TP-1.

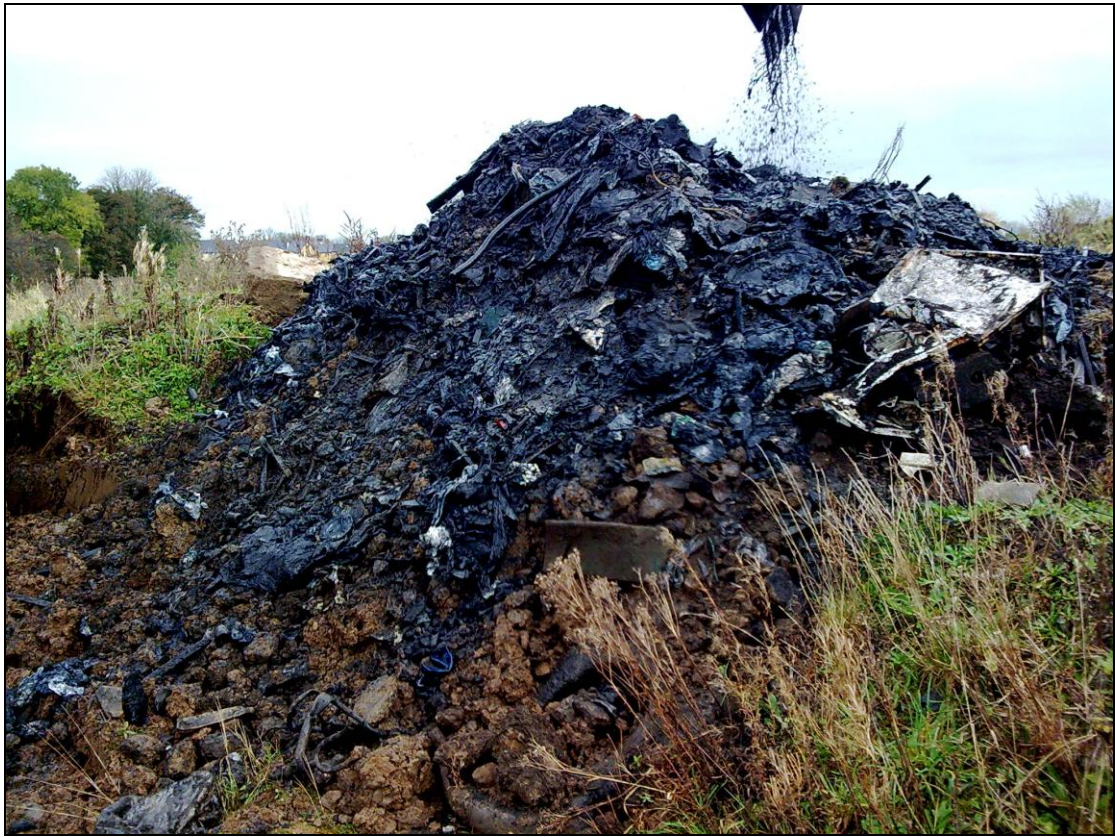
Photo 2 Waste in TP-3.

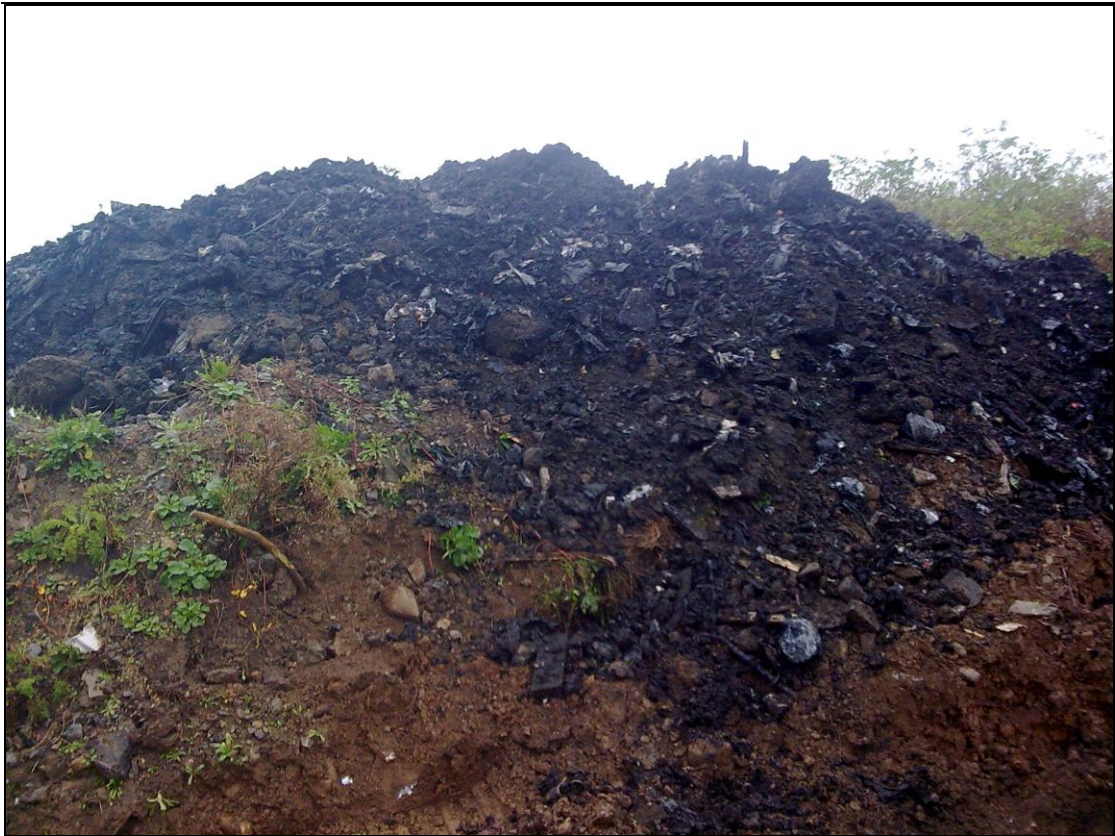
Photo 8 Waste in TP-11

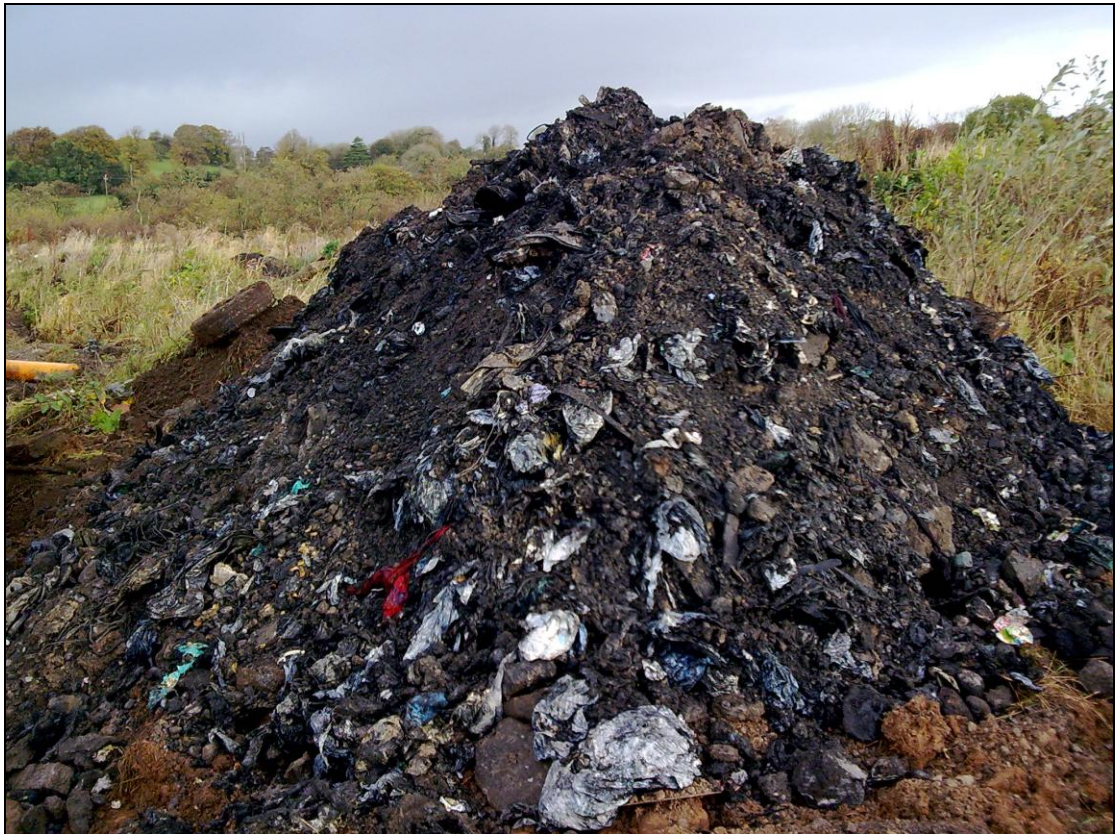
Photo 3 Waste in TP-10

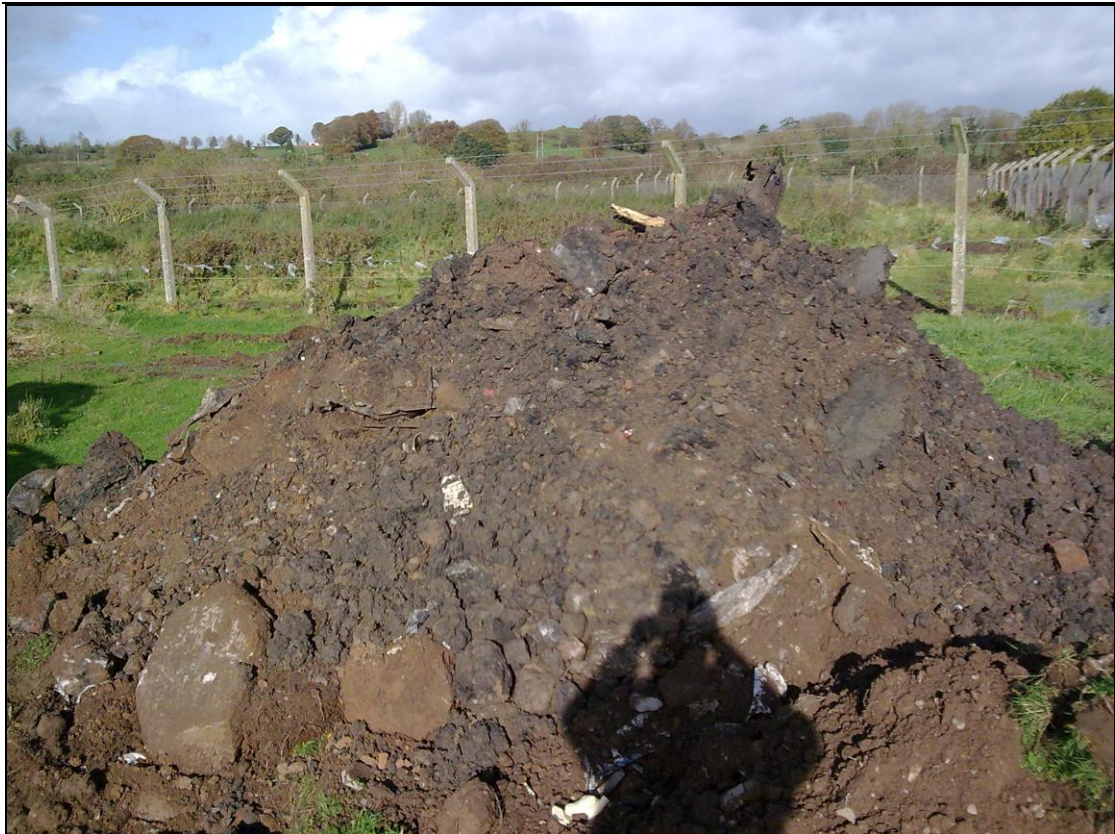
Photo 4 Waste in TP-13

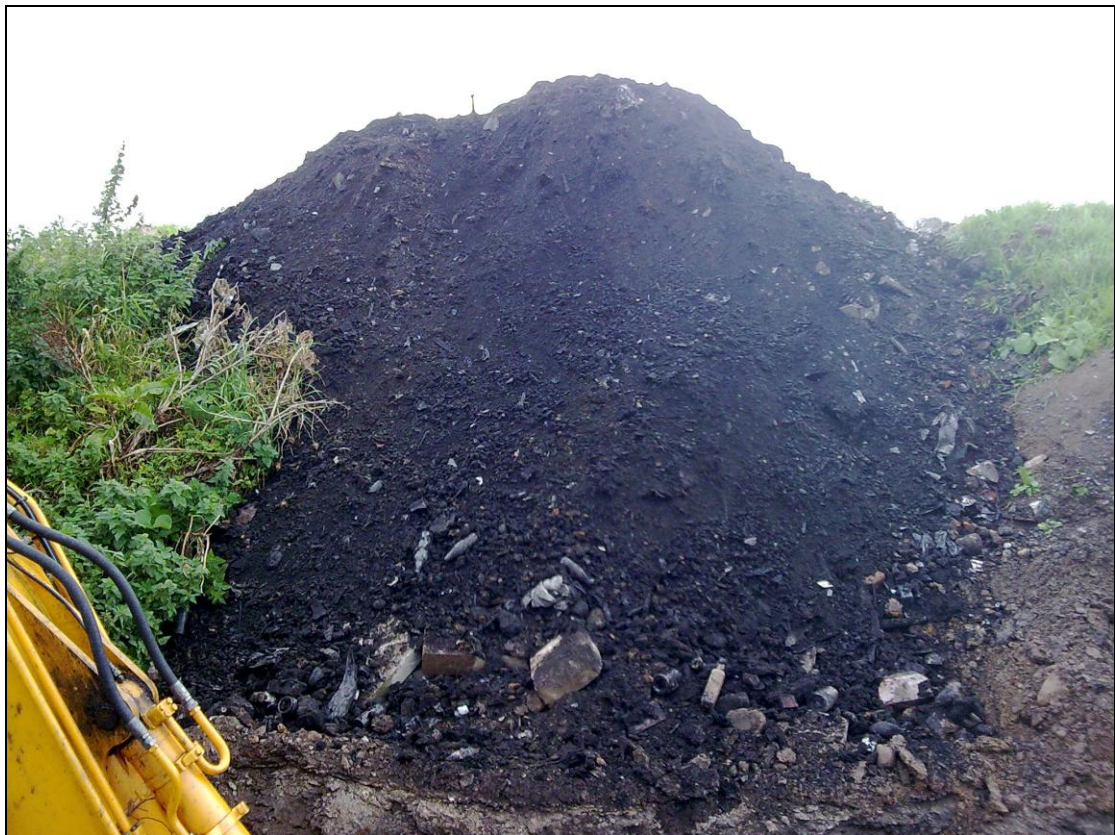
Photo 5 Waste in TP-15

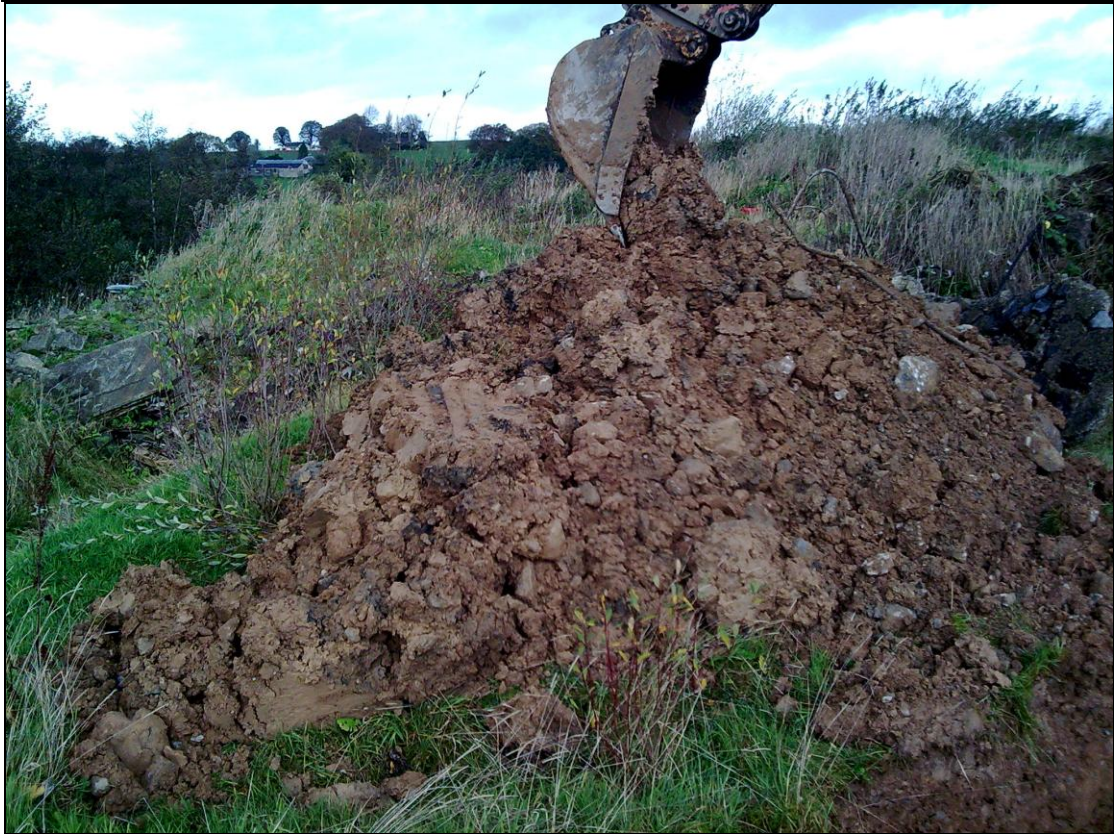
Photo 6 Waste in TP-17

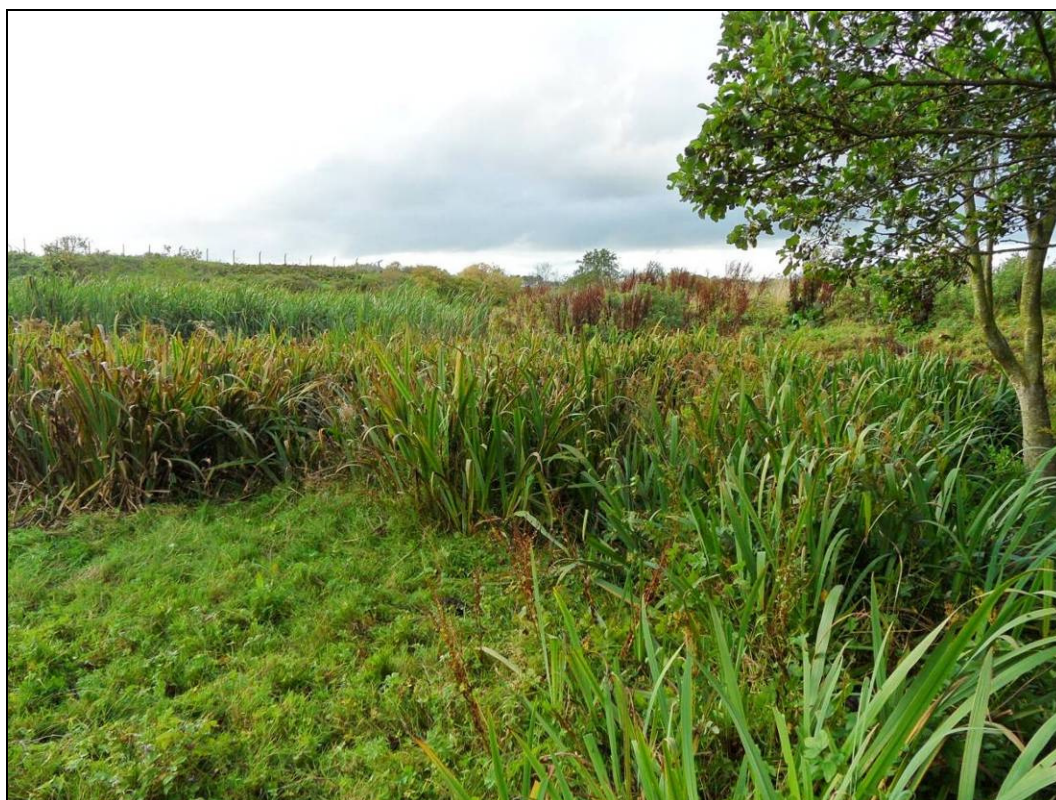
**Plate 2** View of the eastern portion of the reed swamp, where it discharges to the land drain. Emergent flora within the swamp and drain were searched for whorl snails.

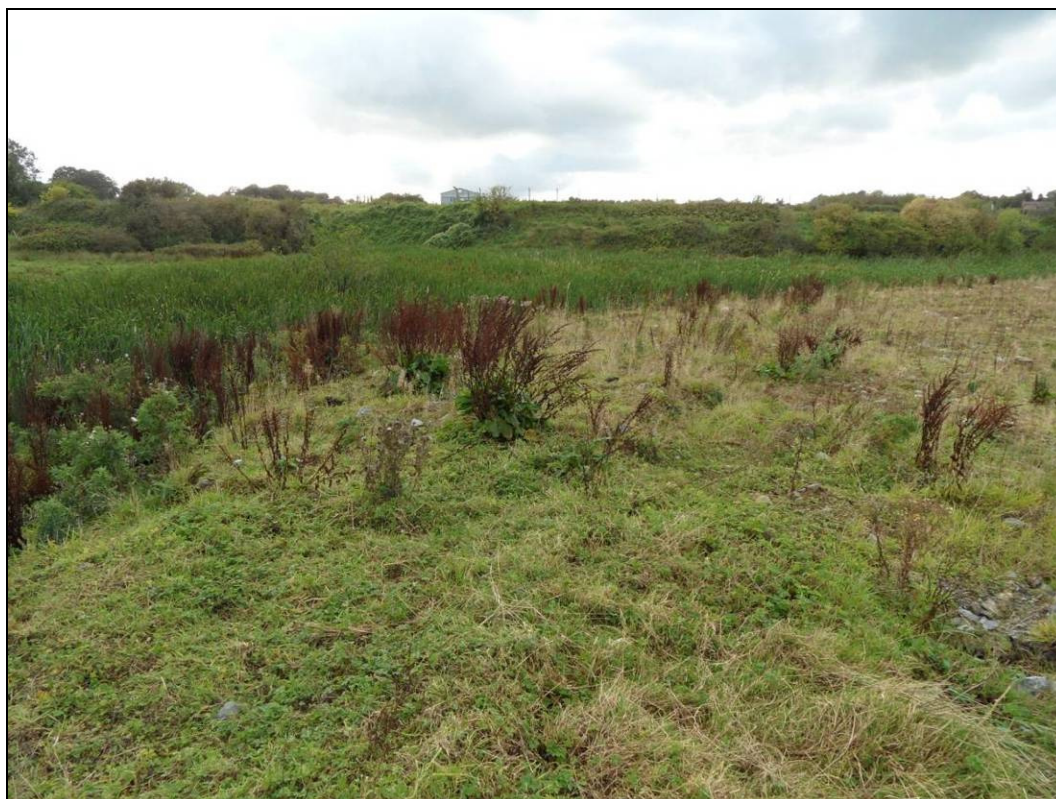
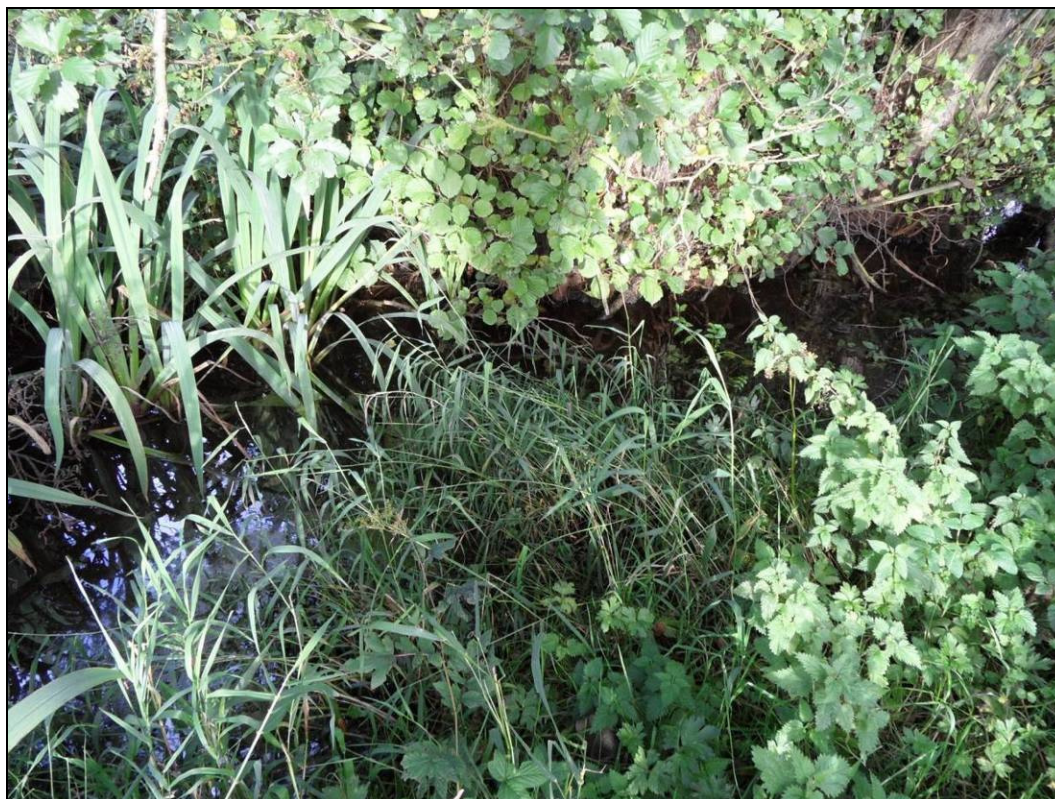
**Plate 3** Water levels in the land drain were found to be very low, with no noticeable flow.

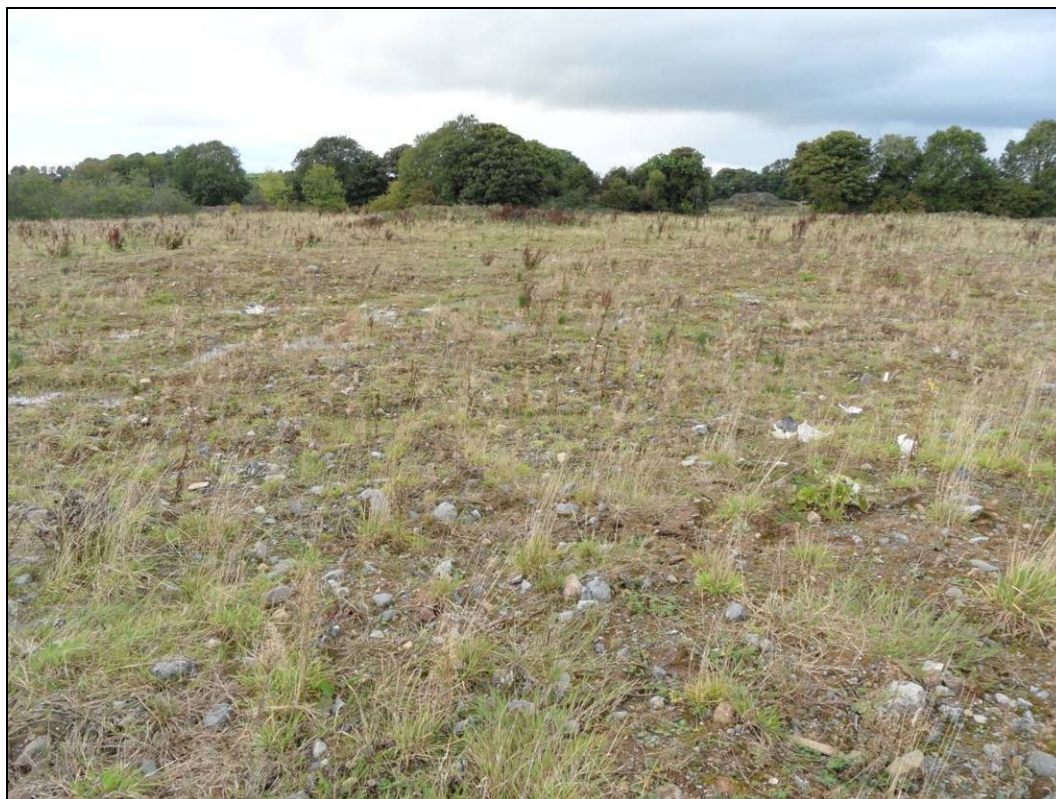
**Plate 5** View north across the recolonising bare ground of the C&D waste spoil.

Spoil has been deposited over a large area to the east of the reed swamp fringing the eastern side of the landfill. This has raised the level of the land creating open fields with a densely compacted and dry topsoil. Perennial rye-grass, docks, ribwort plantain and daisy *Bellis perennis*, species commonly found in agricultural habitats were recorded. Rye-grass indicates re-seeding for agriculture, and close cropped sward and heavy poaching indicates the area is used to graze horses. The recolonising bare ground element is evident in the compacted soil surface and sparseness of vegetation present.

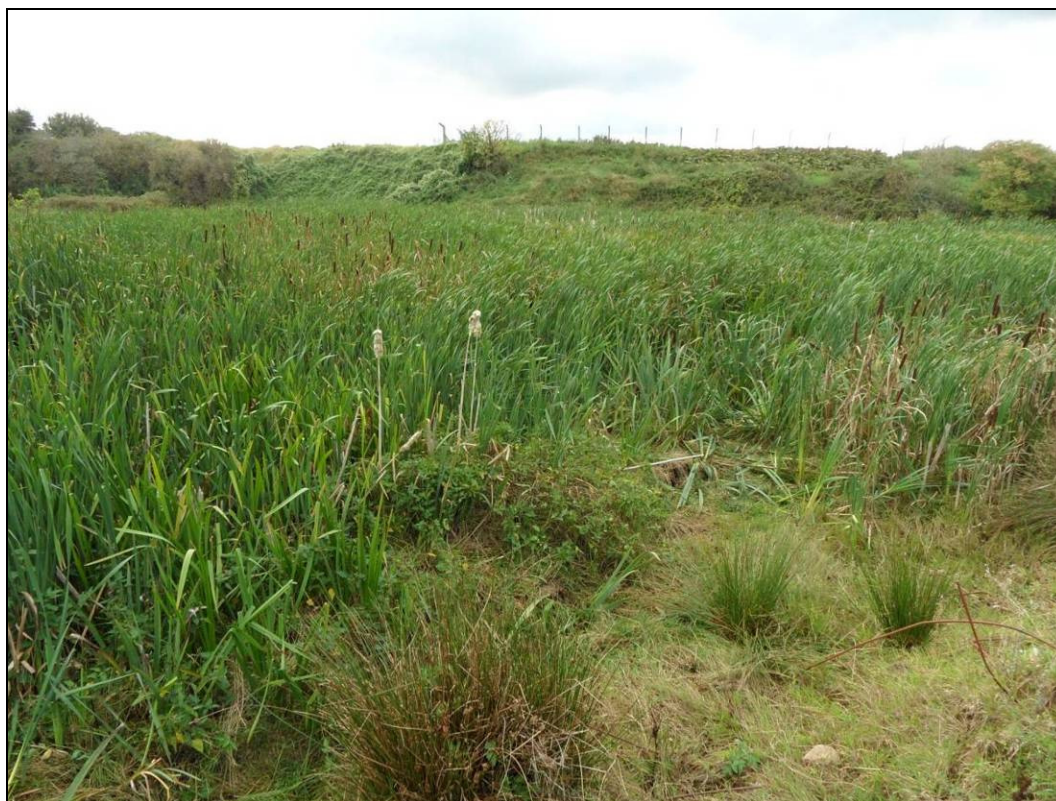
**Plate 6** View of the drier margins of the swamp where the C&D spoil has altered the water table.

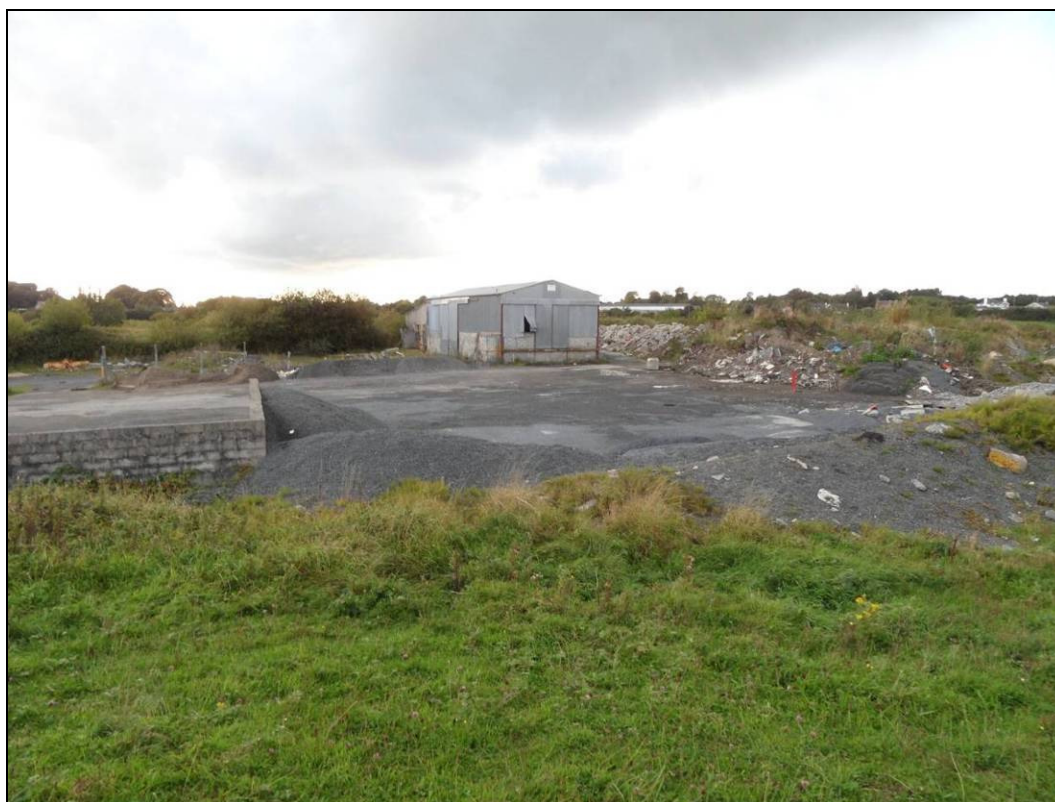
**Plate 12** View of the old buildings and material storage on the closed landfill site.

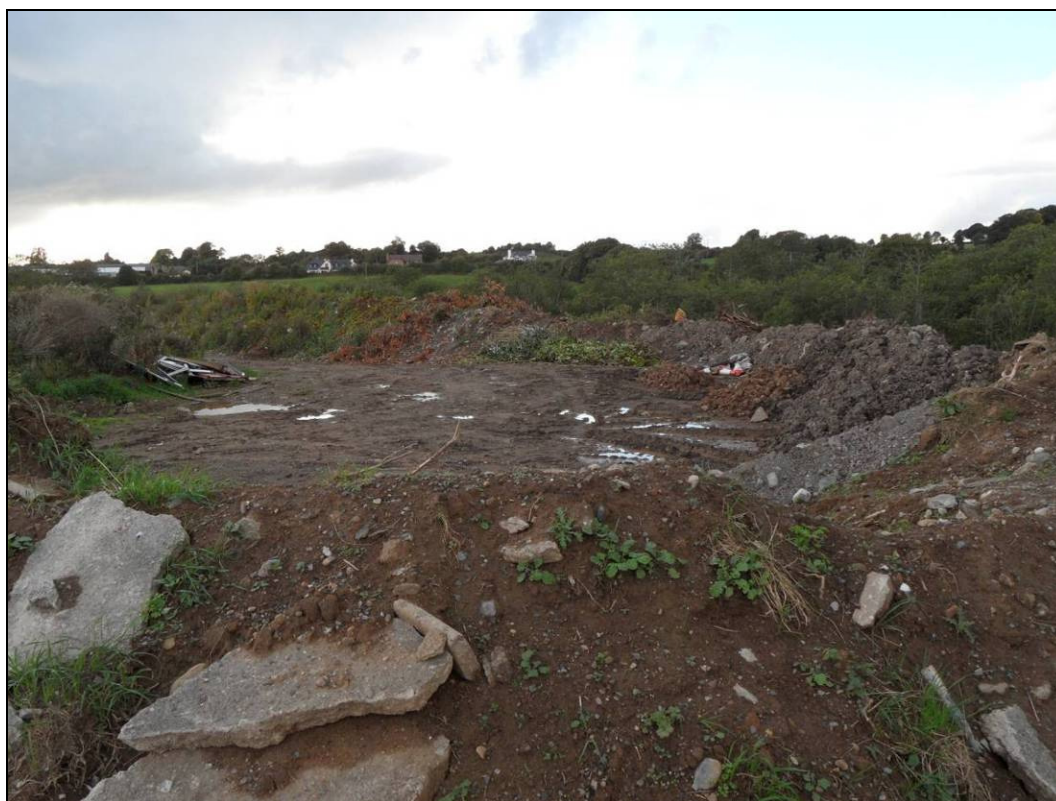
**Plate 14** To the north of the fenced compound on the landfill there is an area of freshly dumped topsoil, construction waste and vegetation. This is piled along the embankment at the edge of the swamp habitat.

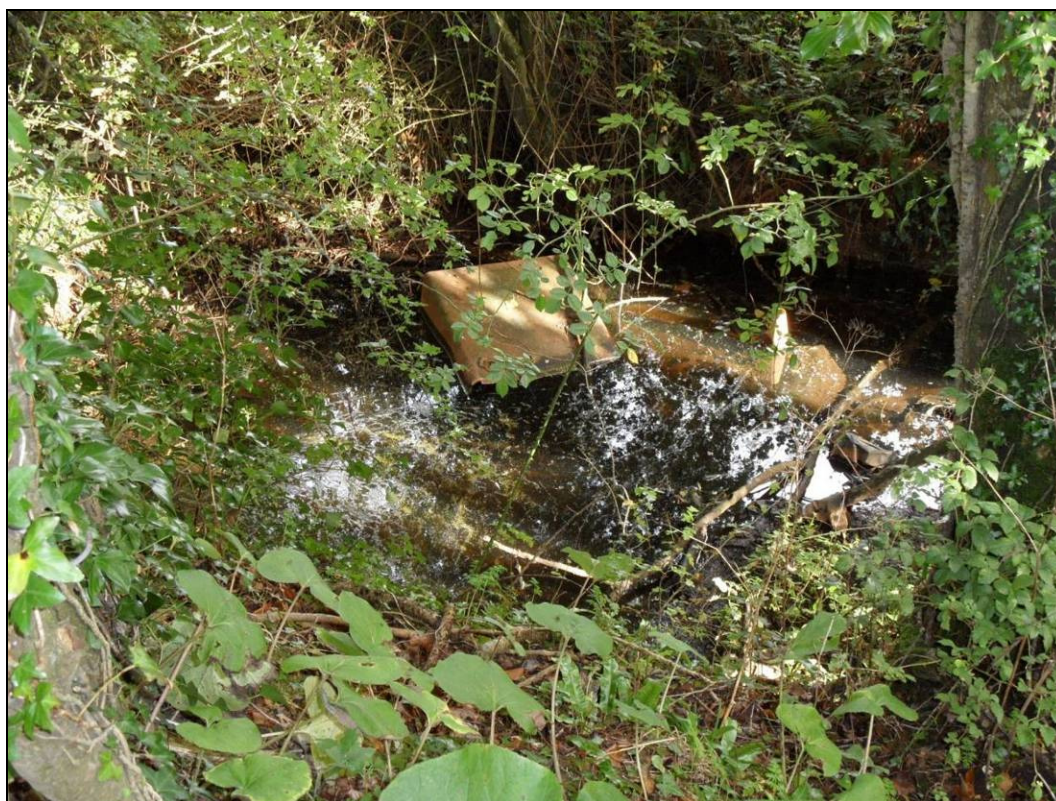
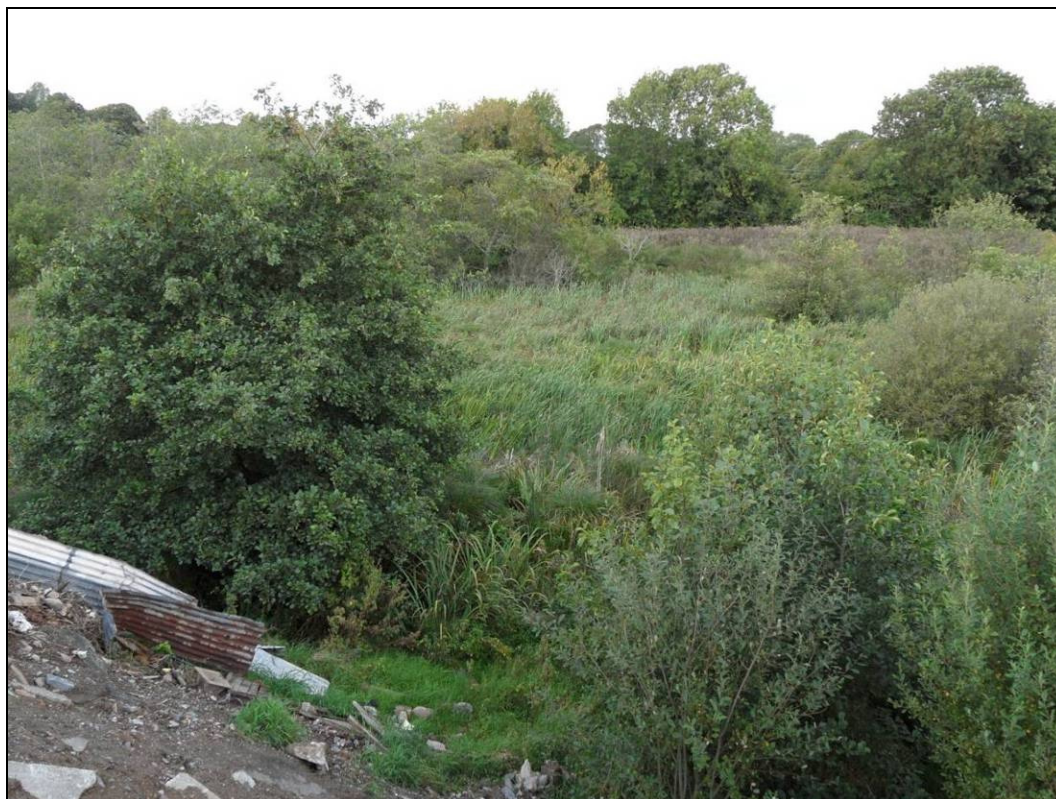
**Plate 15** The dumped material was found to be unstable and slipping downslope into the swamp habitat. It is expected that suspended solids and run-off from this waste is washing down into the swamp.

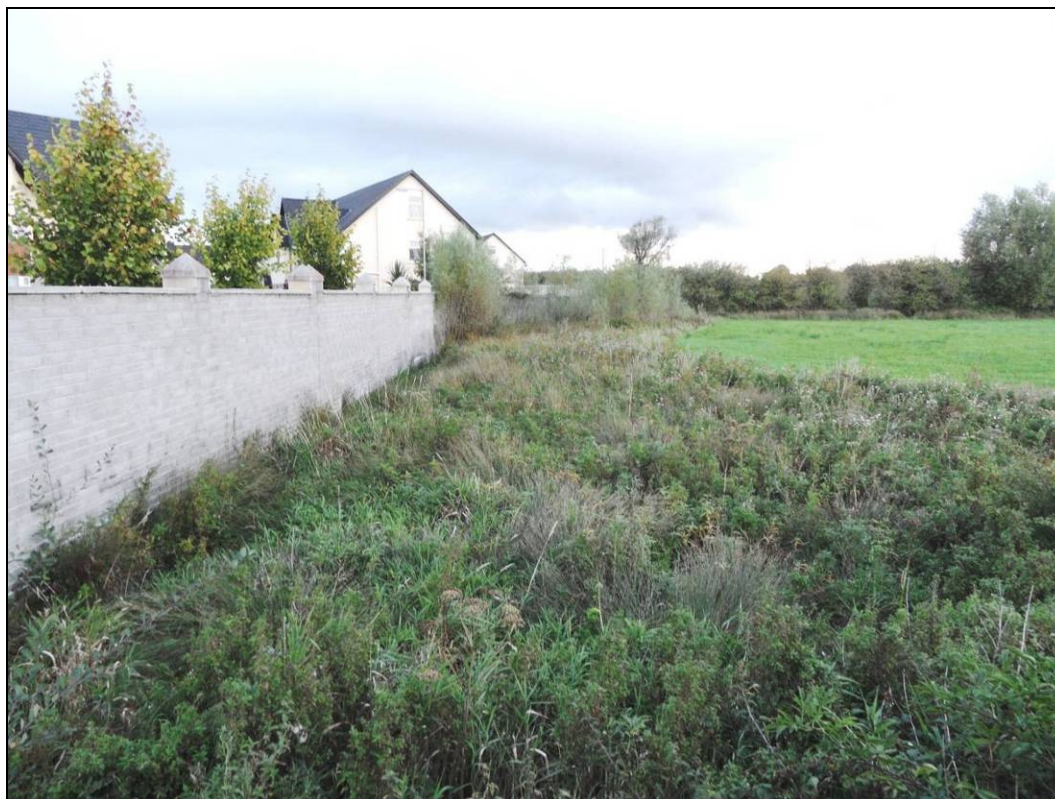
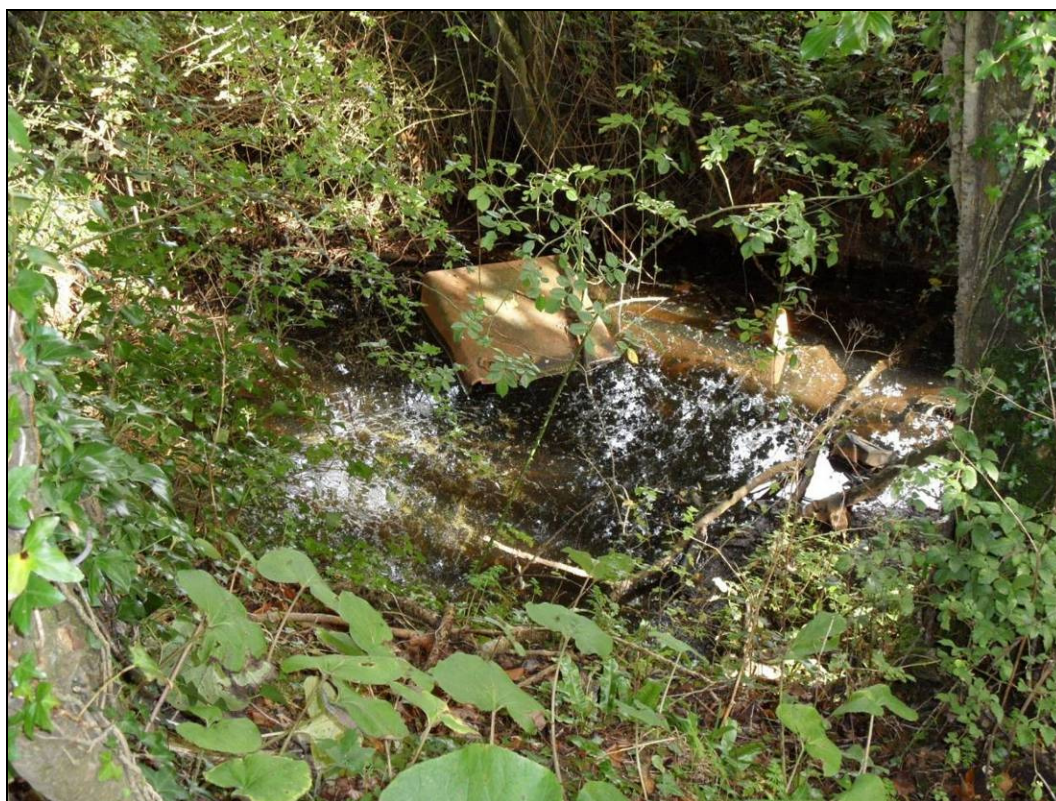
**Plate 16** The land drain due south of the landfill was found to be impounded. No flow was recorded from the drain downstream. Pooled water was recorded directly adjacent to the road.

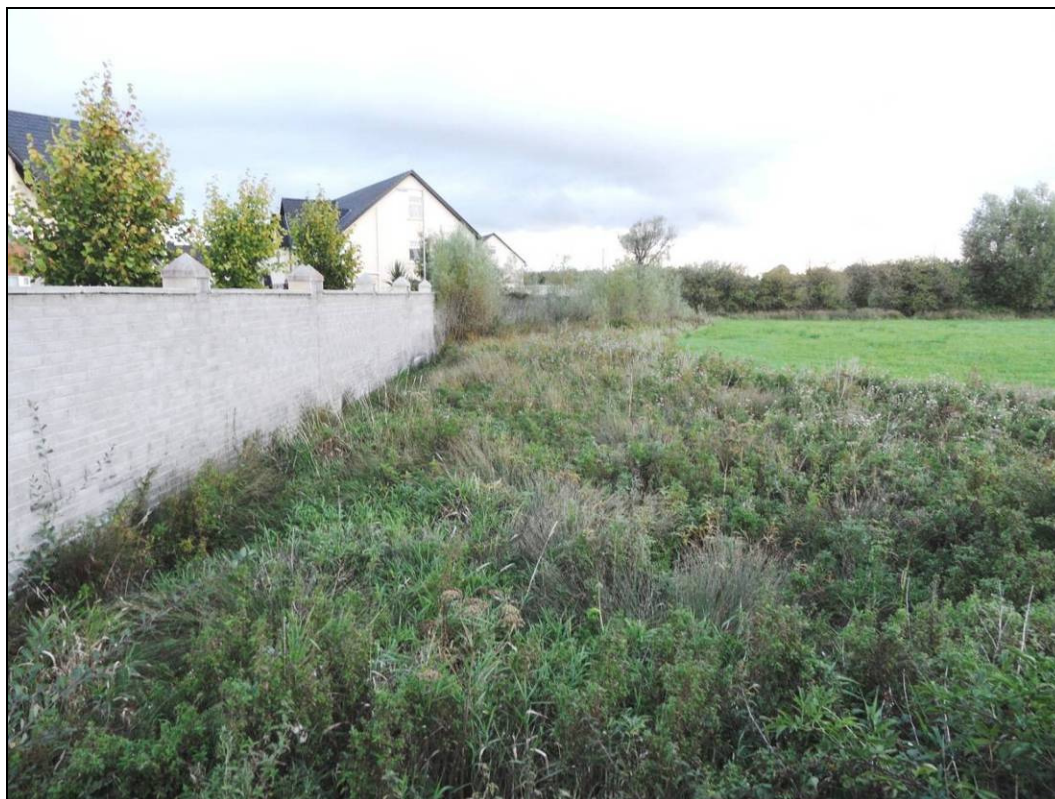
**Plate 17** View north from Rosanna Road. No flow was recorded from the land drain due south of the closed landfill, at Rosanna Road. The construction of new residential developments as depicted and across the road to the south are likely to have altered the flow of this drain. The wet grassland / marsh habitat visible in this image is attributed to frequent high water levels within the land drain.

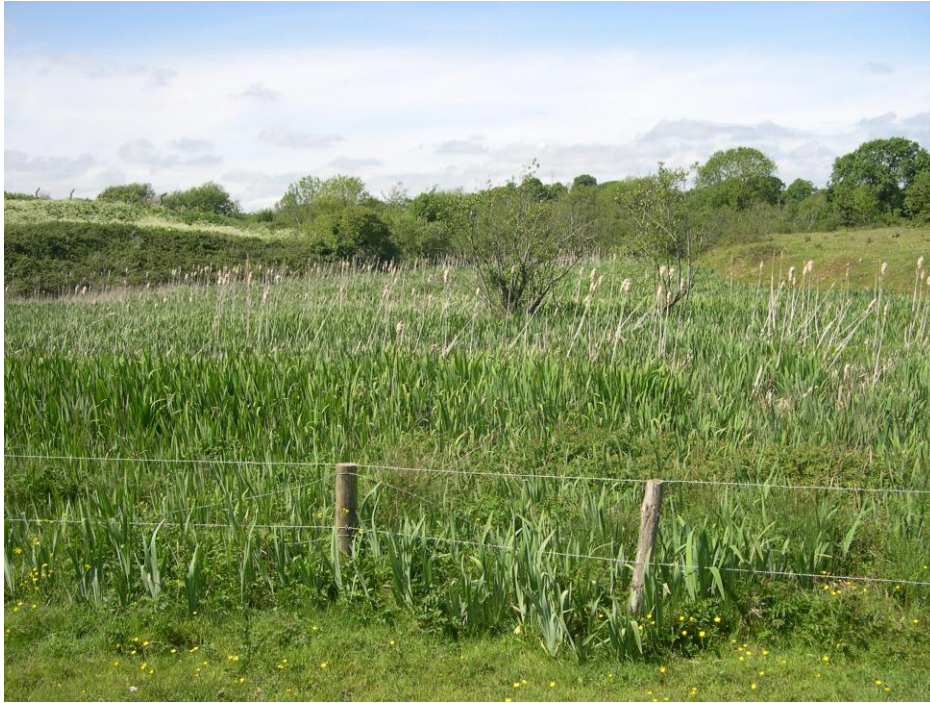
**Photo 2: Drain upstream of culvert**

On the eastern side of the site of the historical landfill, there is an area of marsh (Photo 1, Appendix 5). This marsh drains via a silty channel flowing southwards along a field boundary (Photo 2). At the time of fieldwork, the flow rate was very slow and filamentous algae dominated the channel. Banksides are grazed by equines. The aquatic habitat is unsuitable for any protected species and no protected terrestrial plant species are present. This small watercourse then passes through c. 1km of culvert before emerging from under the N24 road, after which it flows for c. 100m along a field boundary (Photo 3) to its confluence with the River Ara at ITM 589464 635469 (see Appendix 2). The open sections of this drain are classified by the Fossitt (2000) system as FW4. The flow type of River Ara in the 1km section downstream of the drain consists mainly of moderate glide over a substratum of stone and silt (Photo 7), with a few short shallow and faster-flowing sections, such as at the railway crossing and downstream of the bridge by the WWTP entrance (Photo 5). Downstream of this bridge, the natural flow is interrupted by a low hydrometric weir (Photo 6). Near the downstream end of the 1km section, there is a crossing point for cattle (Photo 8), which is causing some added siltation. At Cordangan Bridge (Photo 9), the N24 Bridge (Photo 10) and Bansha Bridge (Photo 11), there are fast-flowing stretches of riffle over cobble and gravel. At the lowermost two bridges the River Ara consists of slower-flowing and deeper glide (Photos 12 & 13). By the Fossitt (2000) system, the River Ara is classified as Habitat Code FW1/FW2. The Aherlow River in the vicinity of the Ara confluence (Photo 14) is fast-flowing over a stony substratum. It is classified as Habitat Code FW1.
