# TIPPERARY TOWN HISTORICAL LANDFILL REMEDIATION

## APPROPRIATE ASSESSMENT SCREENING REPORT AND NATURA IMPACT STATEMENT FOR TIPPERARY TOWN HISTORICAL LANDFILL REMEDIATION

**Abstract:** This document comprises the Stage One: Appropriate Assessment Screening Report and Natura Impact Statement for the Historic Landfill at Carrownreddy, Tipperary Town. Appropriate Assessment is required under Article 6 (3) of the Habitats Directive for any project or plan that may give rise to significant effects on a European (Natura 2000) site.

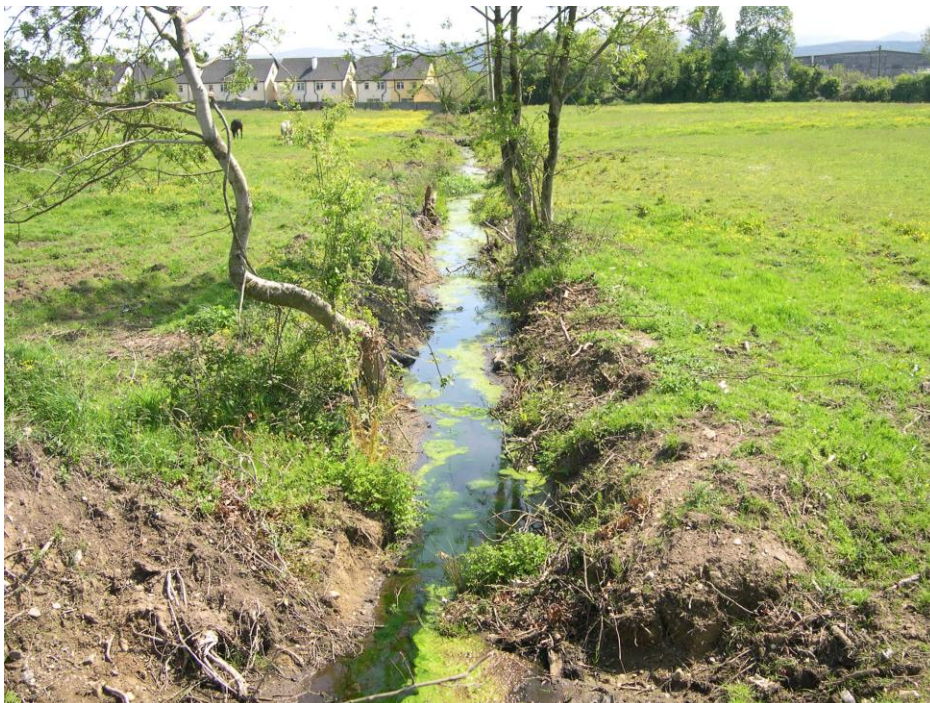
**Photo 3: Drain between N24 and River Ara**

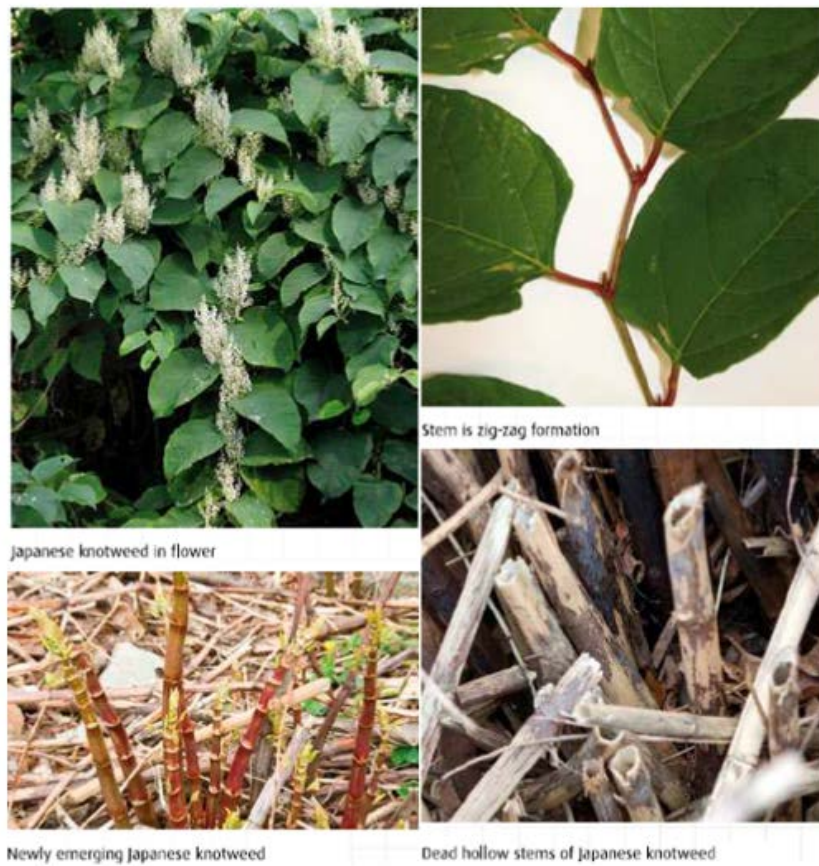
**Plate 1: Characteristic features of Japanese Knotweed**

Red/purple shoots appear early in spring, which in some cases resemble an asparagus-like appearance but, as the canes grow, the leaves unfurl and the plant takes its more characteristic appearance. The mature canes are like bamboo, being hollow, and have a characteristic pattern of purple speckles.

The leaves are shield-shaped with pointed tips and a flat base, arranged in a zig-zag formation. The plant can grow to over 3m in height. Flowering occurs in late summer/autumn (End July – typically August) and consists of small creamy white flowers. During the winter the leaves die back and reveal orange/brown woody erect stems. Rhizomes are bright orange inside and can extend to a depth of 3m and a width of 7m around the visible growth above ground. Plate 1 below displays characteristic features of Japanese Knotweed.

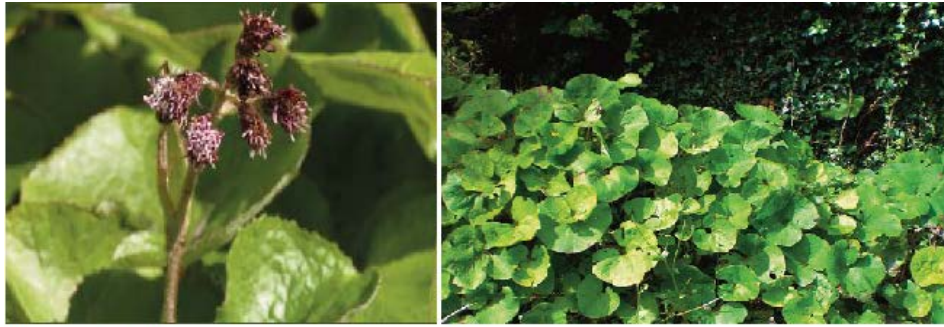
These deciduous plants produce large roundish leaves up to 30cm in diameter. These are downy underneath. Its pale pink flowers have a distinctive sweet smell and flower in December and January. Foliage forms a dense carpet with a height of approximately 30cm. Its rhizomatous root system allows vegetative spreading. Plate 5 displays some characteristic features of Winter Heliotrope. The heliotrope plants in Ireland are all clone males, originating from a single male through fragmentation. These male plants are unable to produce seeds and thus rely on root systems and fragmentation to spread.

**Plate 5: Characteristic features of Winter Heliotrope (Source: Transport Infrastructure Ireland)**

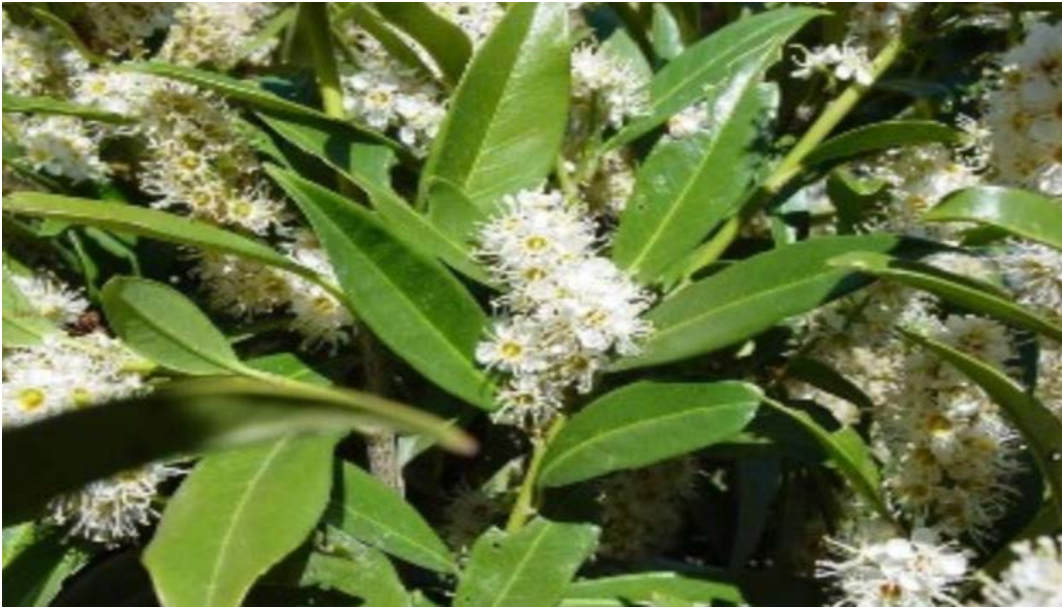
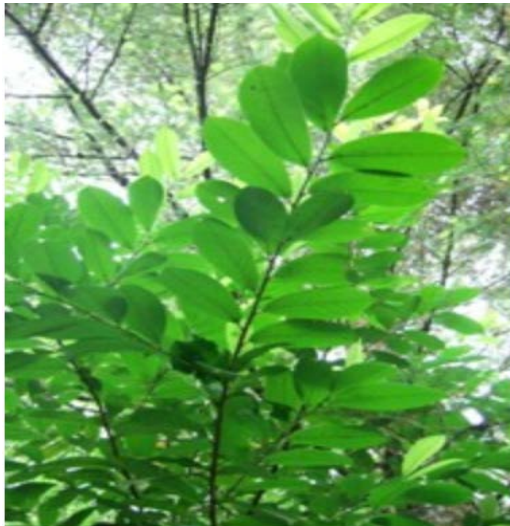
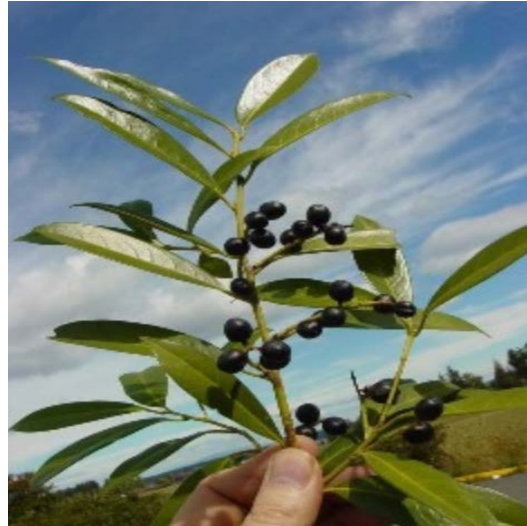
**Plate 7: Characteristics of Cherry Laurel (Source: Kingcounty.gov)**

Evergreen shrub which forms dense thickets comprised of either a single stem or multiple stems (especially if it has been trimmed). Thick evergreen 5-15cm long oblong-ovate leaves; glossy green on surface and pale underneath. Leaves arranged alternately on short leaf stalks and leaf edges are toothed with pointed tips. Small white fragrant flowers are held in clusters (racemes) and flowers are comprised of 5 petals any many yellow stamens. Fruit are purple/black and Cherry like and held in clusters. See Plate 7 below shows the defining features of Cherry Laurel.

Clusters of white flowers

This evergreen leaves alternate on stem with short leaf stalks.

Fruit in clusters.

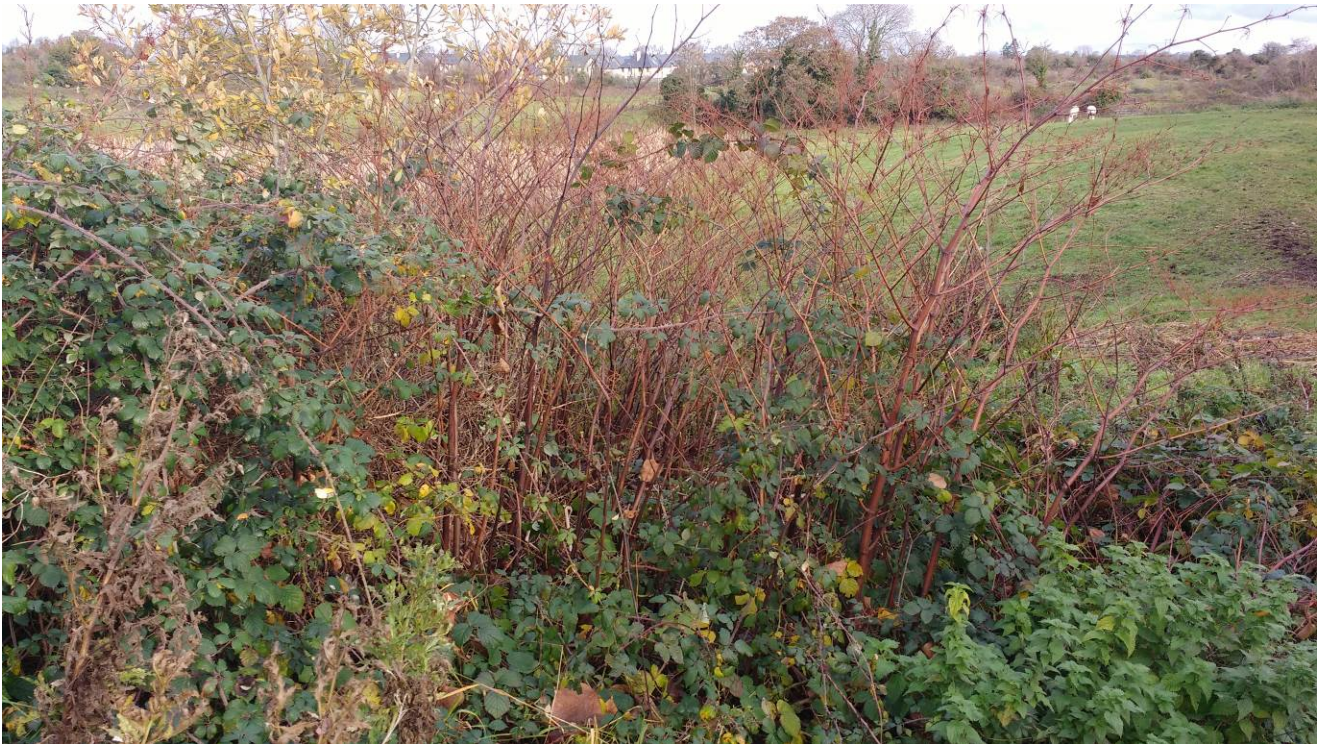
**Plate 1: Japanese Knotweed Area 1**

All canes were dead, brown and dry when inspected; needle marks and stem staining were observed on most stems examined.

As such, treatment is confirmed and appears to have been completely effective.

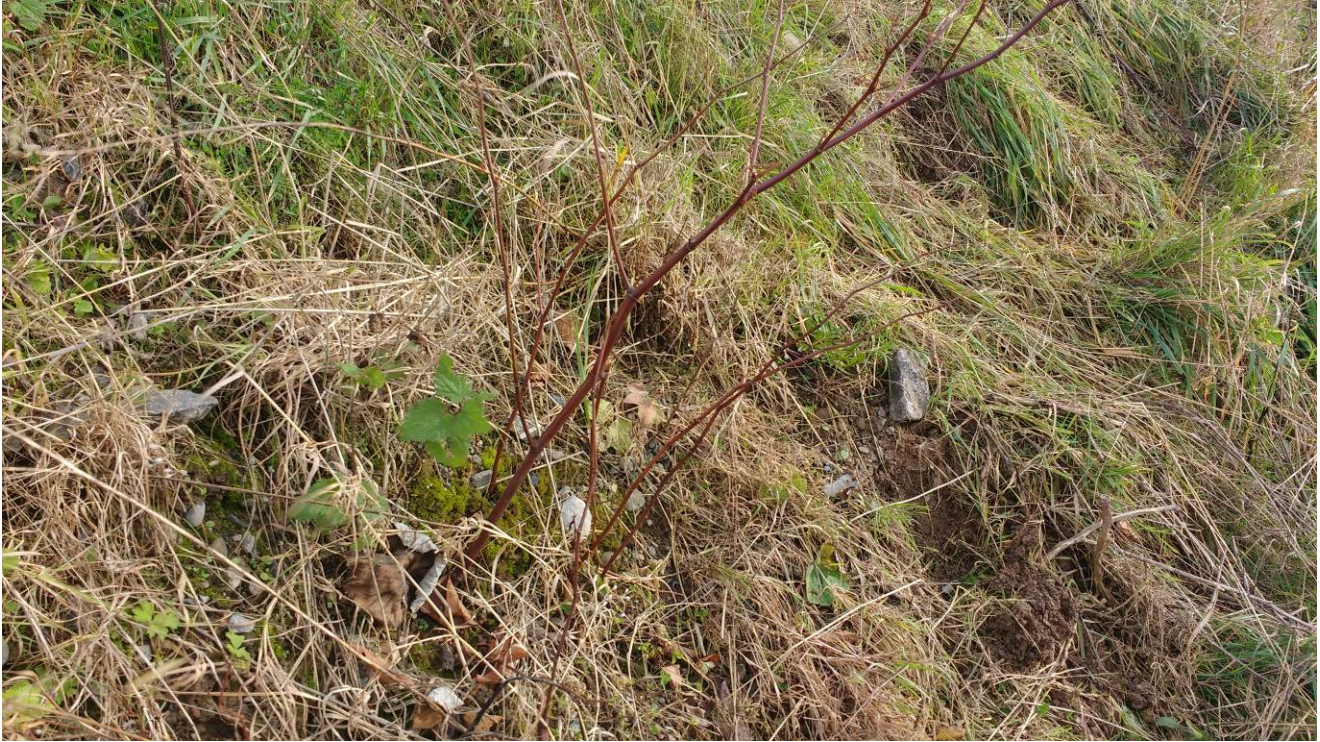
**Plate 2: Japanese Knotweed Area 2**

Japanese Knotweed area 2 consists of several small stems growing from a mound of vegetated spoil within the landfill site.

All canes were dead, brown and dry when inspected, and needle marks and stem staining were observed, confirming treatment was carried out, and was completely effective.

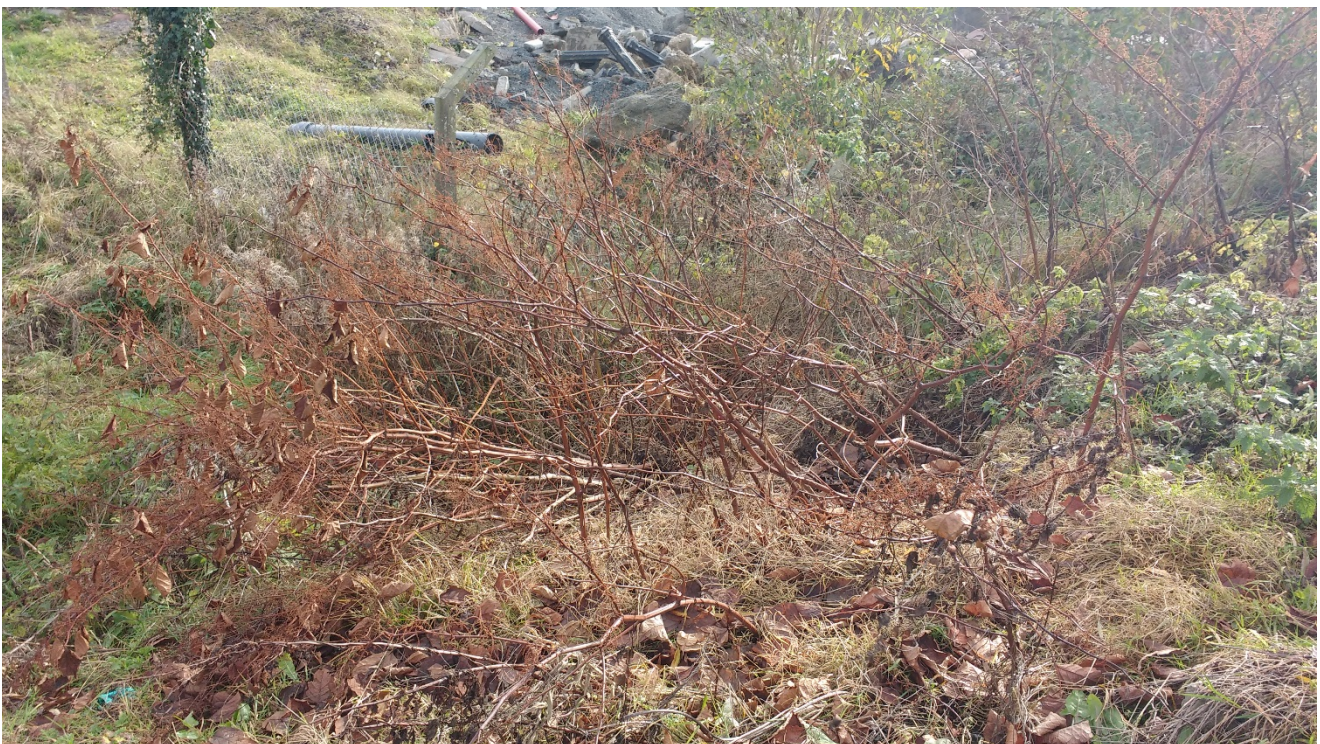
**Plate 3: Japanese Knotweed Area 3**

Most canes were dead, brown and dry when inspected, with needle marks and stem staining confirming treatment was carried out. Several of the larger central canes were still showed signs of life, despite having been injected. As such, while treatment was confirmed to have been carried out, it does not appear to have been as effective as other areas. This may be due to a more resilient central growth. This also illustrates the resilience of Japanese Knotweed and the need for repeated treatment.

Also, of note in this area was disturbance to the growth. Several stems and an underlying clump of rhizome had been dislodged from the upper section of the bank where the growth is located and rolled down the hill but remained within the growth. As such, while disturbed, the Knotweed did not spread. This appears to have been caused by horses, which roam freely through the site, grazing in parts of the landfill.

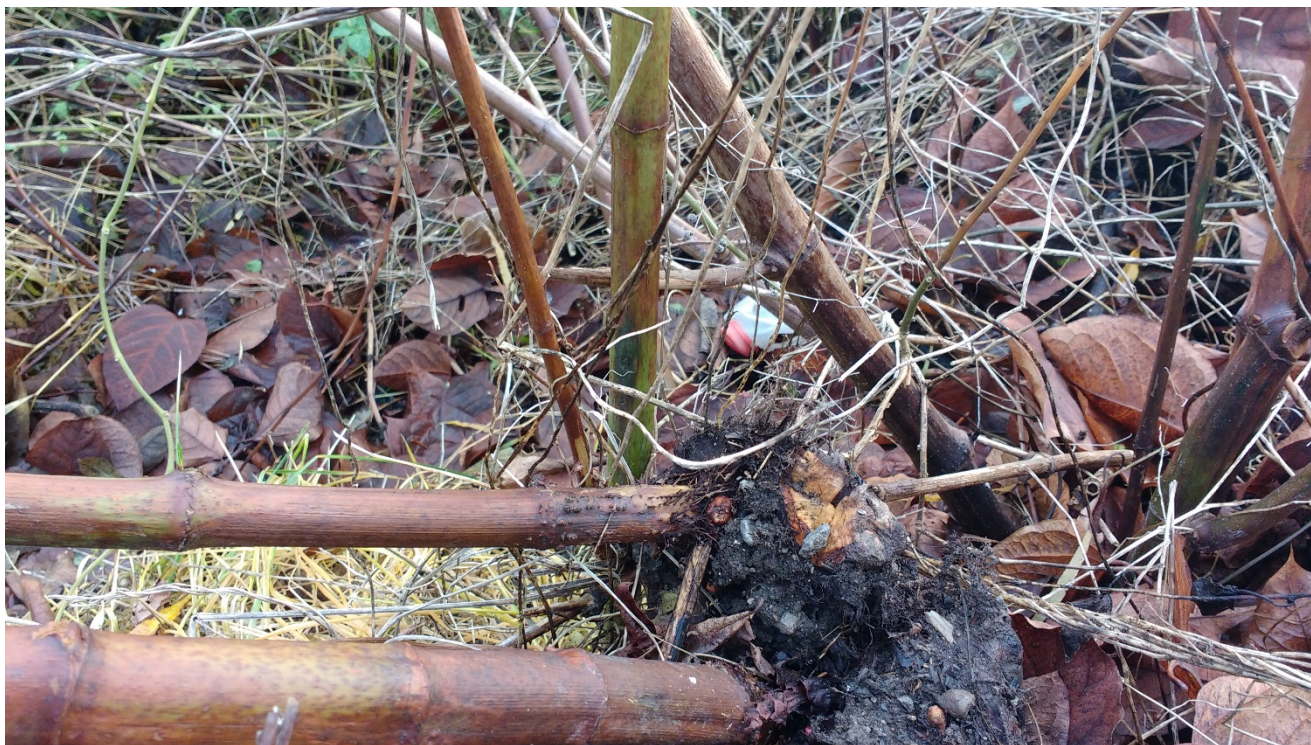
**Plate 4:** treated stem showing discolouration/dye and resistance to herbicide (centre) and dislodged rhizomes/stems (bottom centre and left) at Japanese Knotweed Area 3

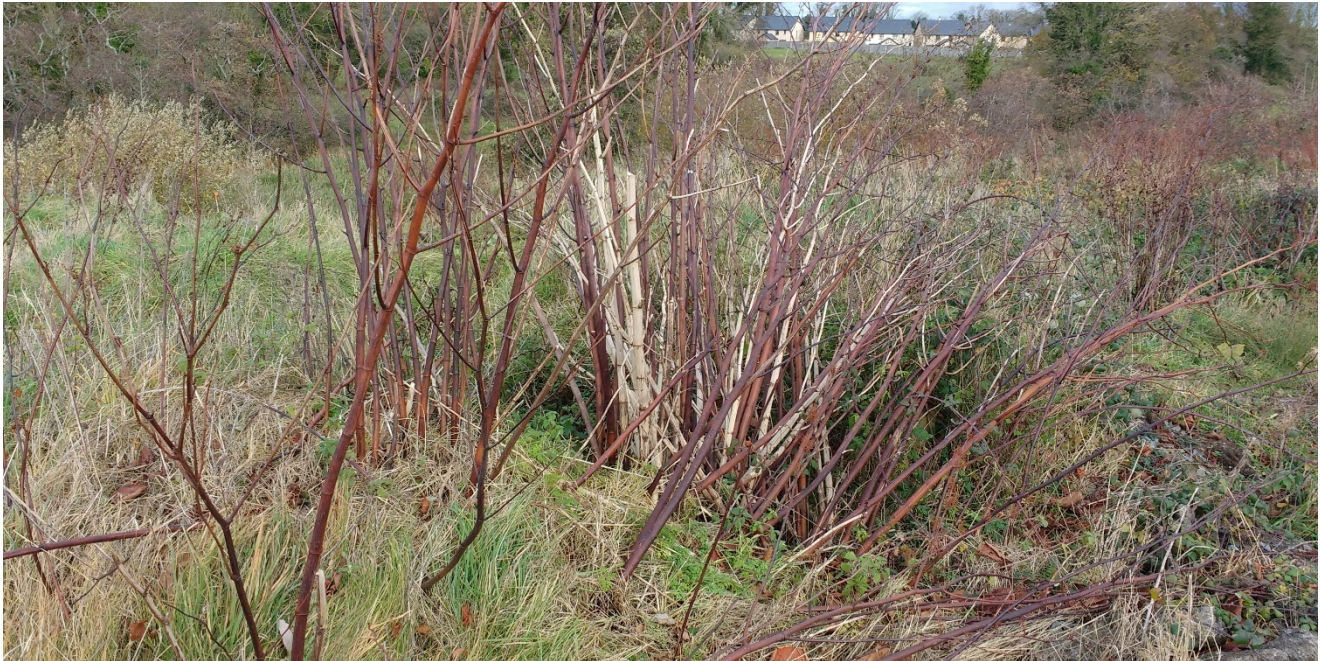
**Plate 5: Japanese Knotweed Area 4**

Area 4 is a small to medium sized stand growing from vegetated spoil within the landfill site. The area is dense and well-established with larger canes common in central areas.

Most canes were dead, brown and dry when inspected, with needle marks and stem staining confirming treatment was carried out. Several of the larger central canes still showed signs of life at their bases. Similarly, to area 3, this demonstrates resistance to herbicide treatment. However, treatment was more effective in this area compared to area 3.

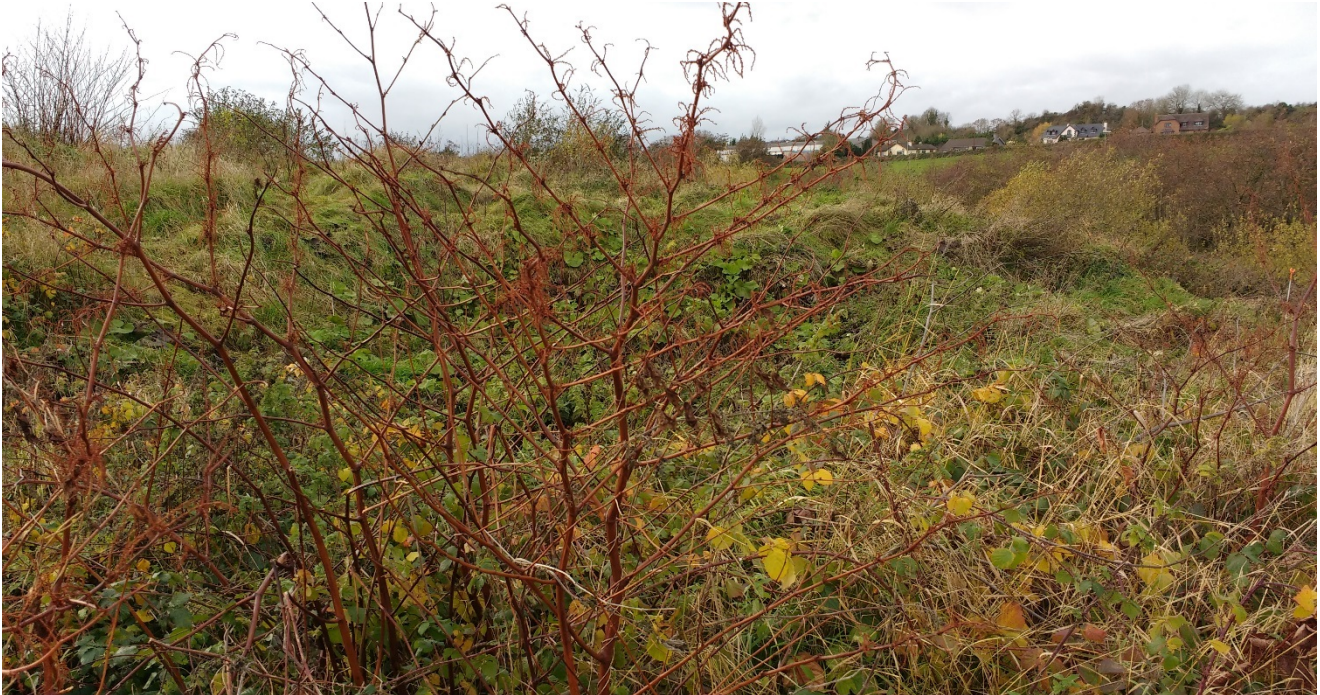
**Plate 7: Japanese Knotweed Area 5**

All canes were dead, brown and dry when inspected, and needle marks and stem staining were observed, confirming treatment was carried out, and was completely effective.

A dislodged group of older dead stems (natural die-off from the previous year) and attached rhizome were present in the middle of the growth. This may have come loose from the unstable substrate after dying off or been dislodged by horses; the cause is not clear. In any case, no re-growth occurred from the rhizome.

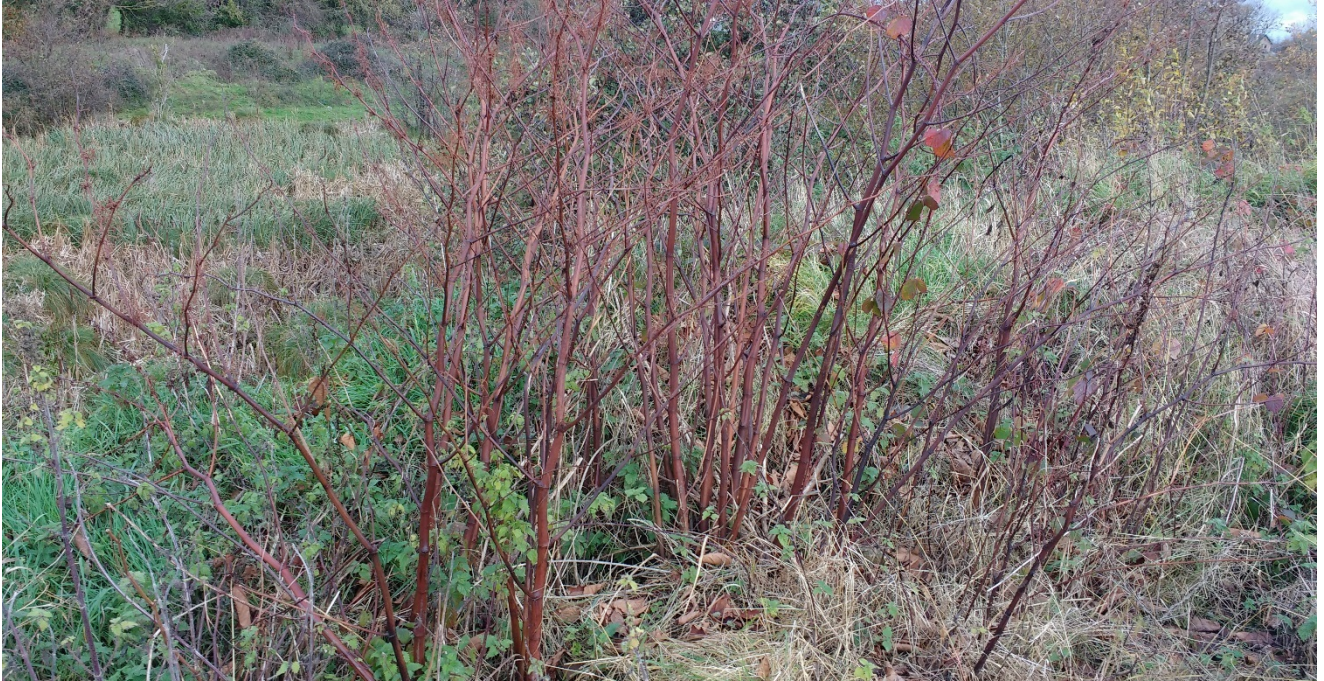
**Plate 8: Japanese Knotweed Area 6**

Area 6 is a small sparse growth of Japanese Knotweed. All canes were dead, brown and dry when inspected, and needle marks and stem staining were observed, confirming treatment was carried out, and was completely effective.

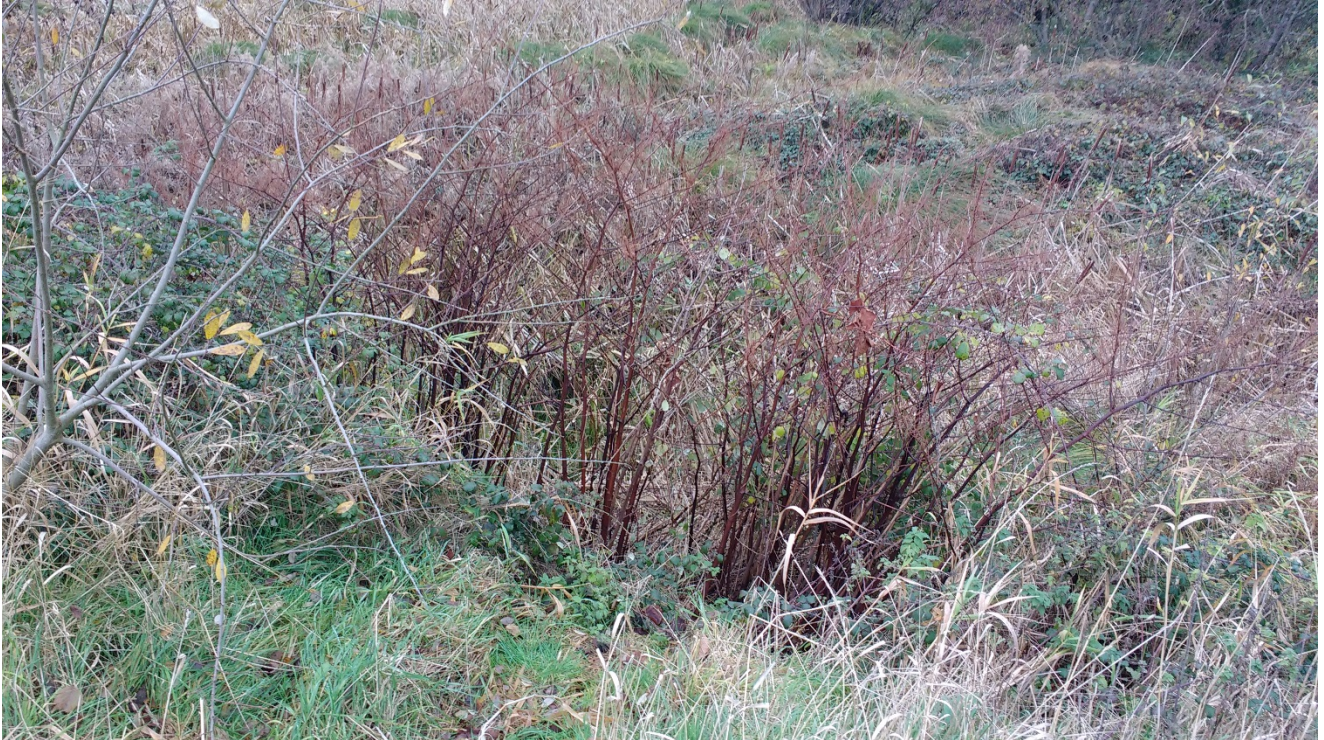
**Plate 9: Japanese Knotweed Area 7**

Area 7 is a small and relatively sparse growth at the base of the landfill mound, fringing the surrounding swamp. The growth is established, but not dense.

All canes were dead, brown and dry when inspected, and needle marks and stem staining were observed, confirming treatment was carried out, and was completely effective.

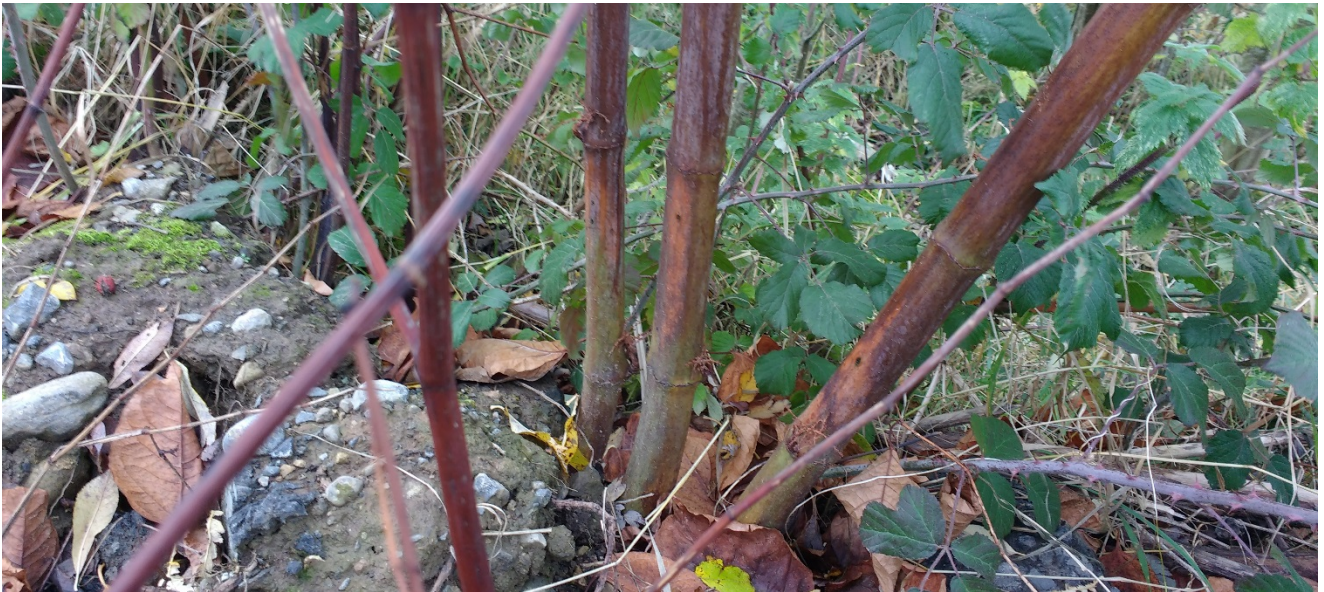
Three large canes showed signs of resistance with the lower parts of stems retaining some green colouring.

As such, treatment was carried out and was largely effective; however, some older and more vigorous growth was resistant to treatment.

**Plate 10: large stems showing needle marks and herbicide resistance (Japanese Knotweed Area 8)**

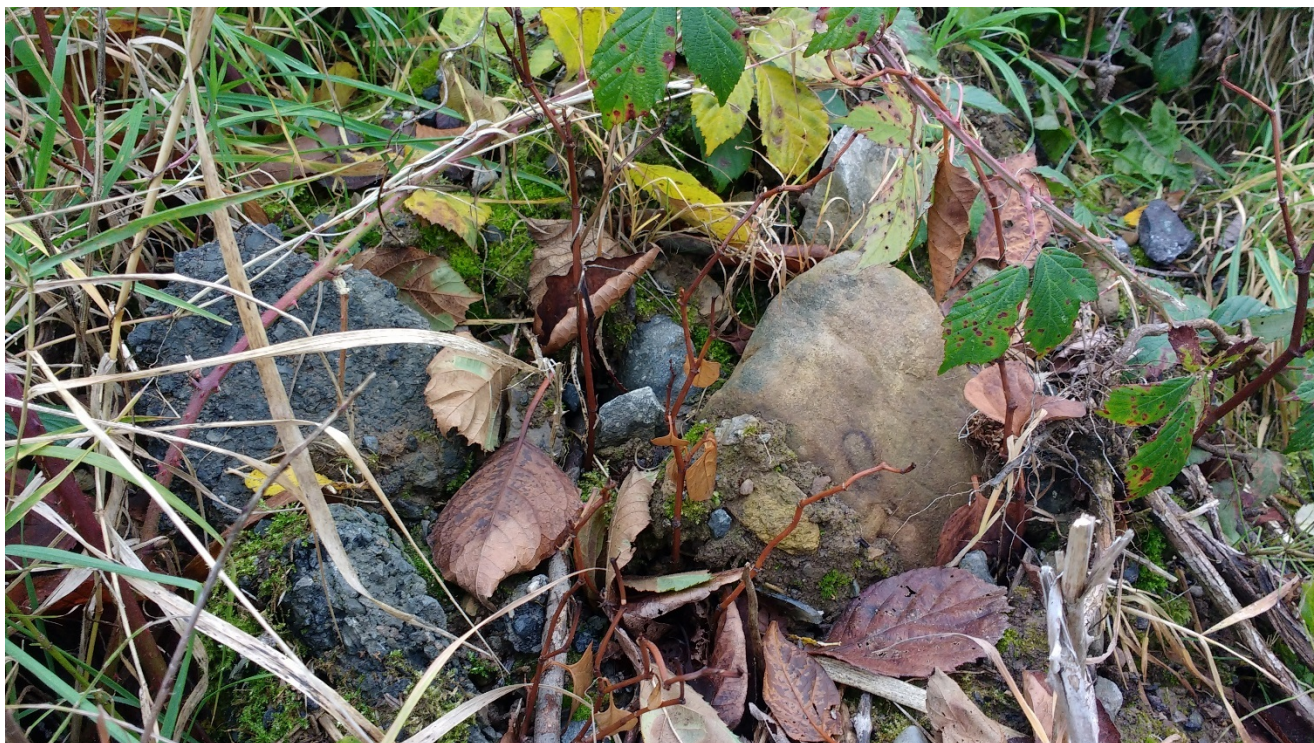
**Plate 11: Small stems showing symptoms of herbicide treatment at Japanese Knotweed Area 8**

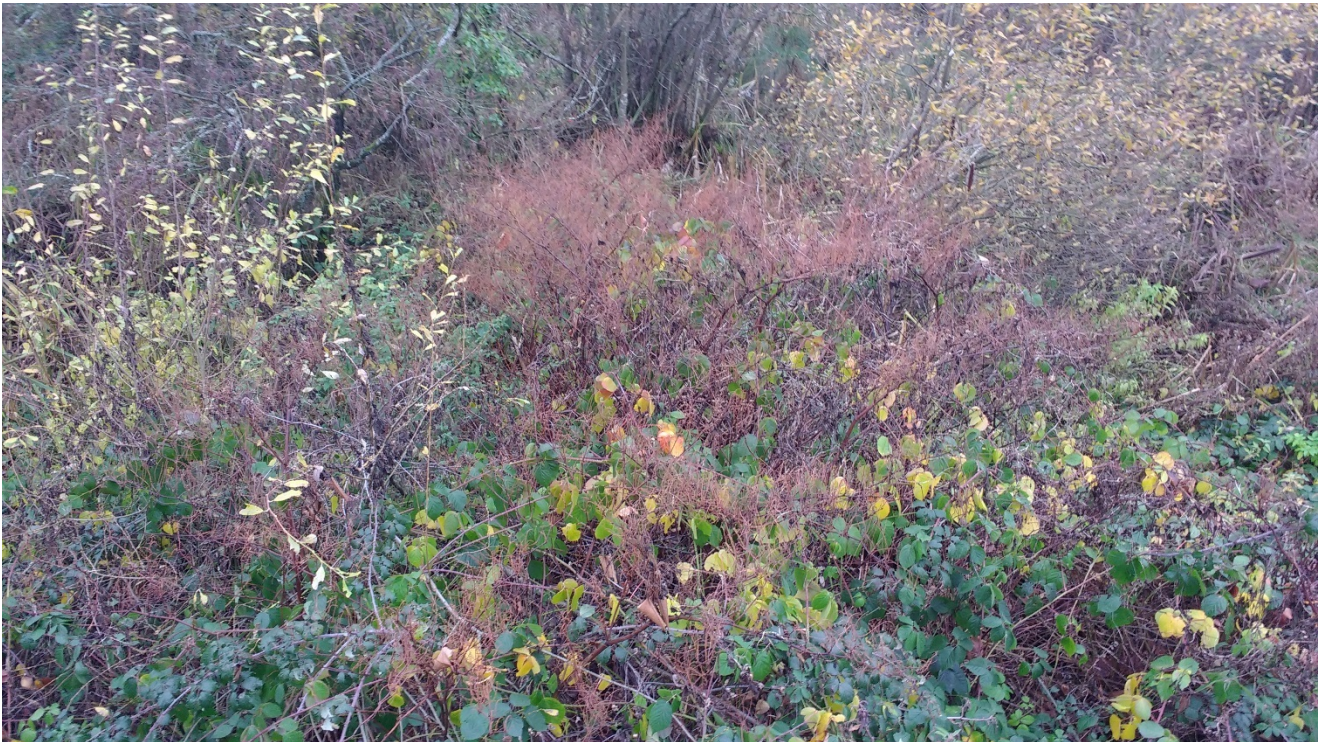
**Plate 12: Newly discovered Japanese Knotweed growth (Area 9) (upper centre)**

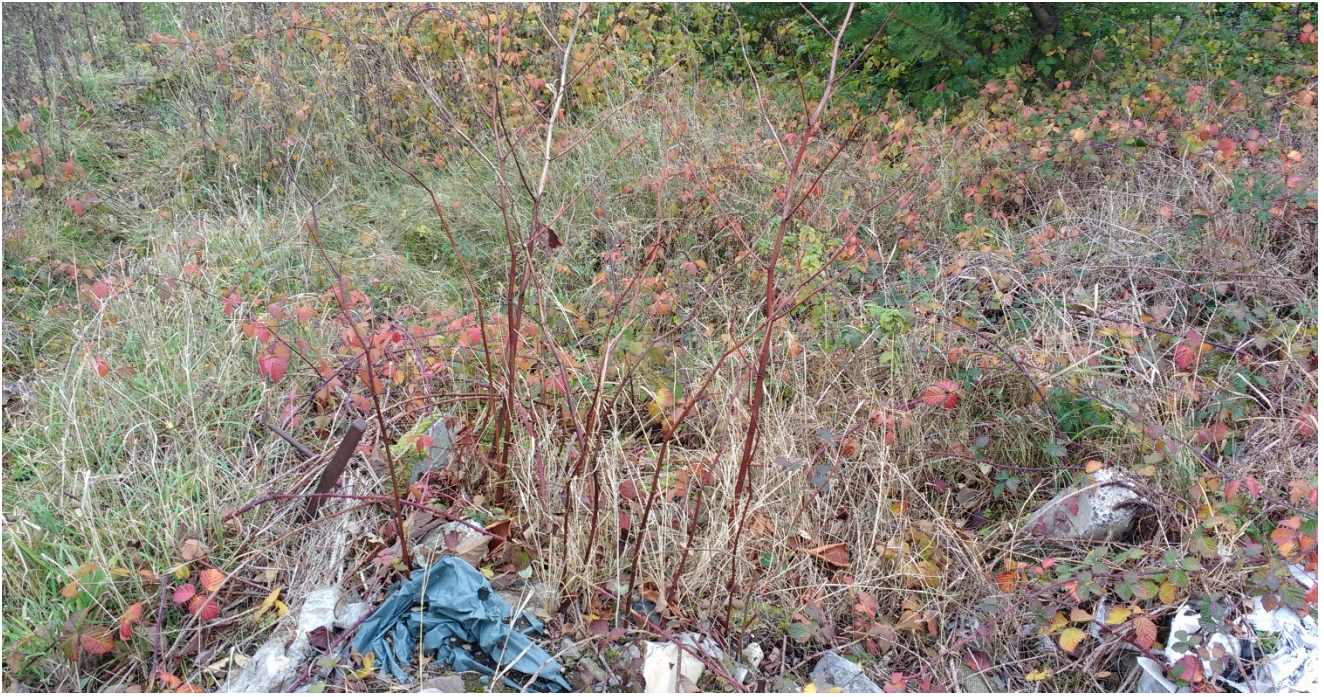
**Plate 13: Japanese Knotweed Area 10**

This is a small, sparse growth near the centre of the landfill mound. All canes were dead, brown and dry when inspected, and needle marks and stem staining were observed, confirming treatment was carried out and was effective.

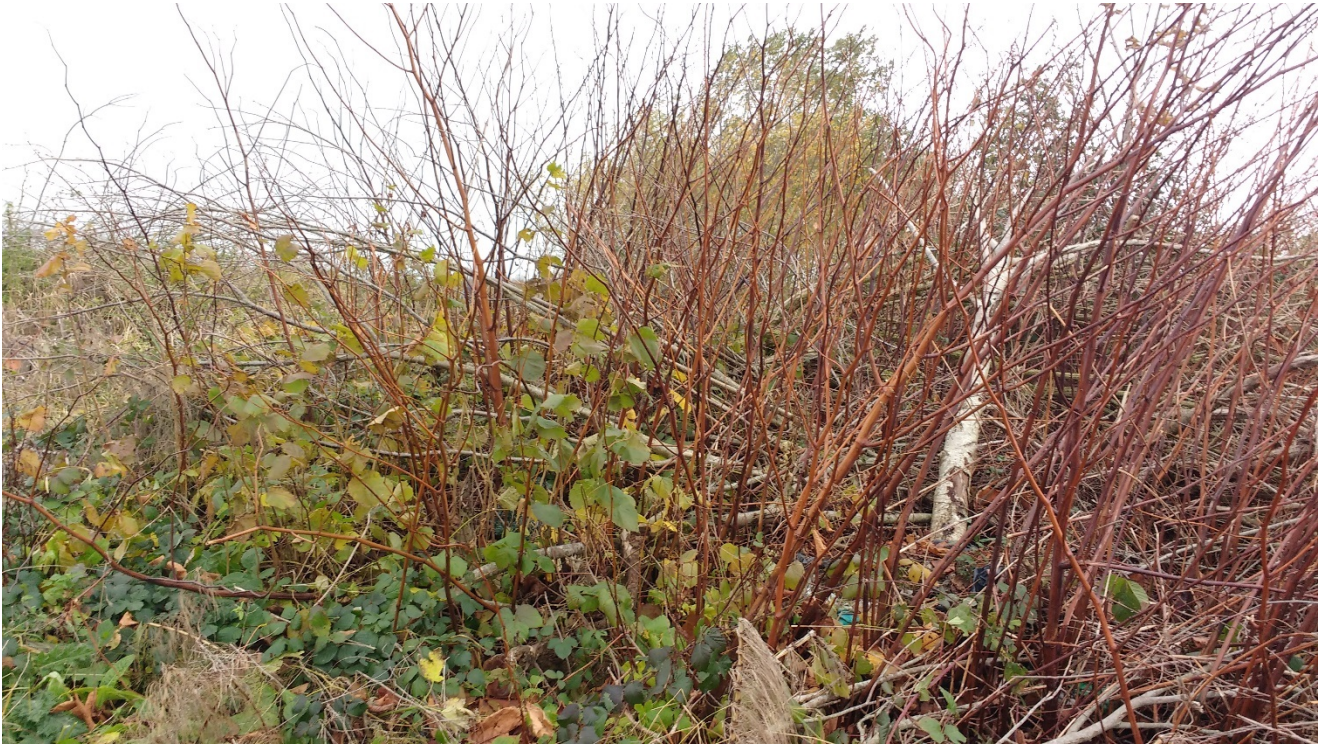
**Plate 14: Japanese Knotweed Area 11**

Area 11 is a large, dense and well-established growth near the centre of the landfill mound. Part of the growth is difficult to access due to the presence of a pile of severed tree branches, which the Knotweed has grown through and around.

Most of canes are brown and have needle marks indicating that treatment was carried out and was largely effective. Several canes at the eastern side were not brown, again demonstrating the challenge posed by treating a large, well-established and vigorous growth.

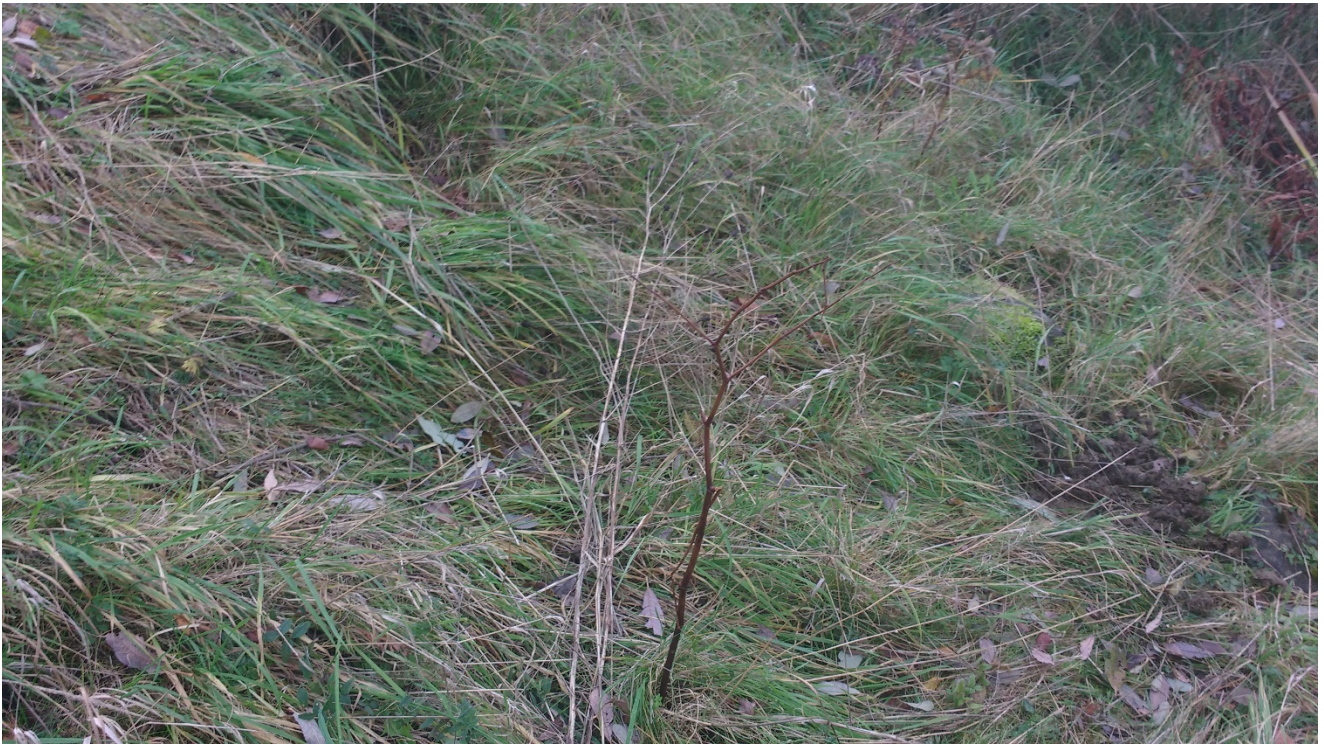
**Plate 15: Waist-height cane at Japanese Knotweed Area 12**

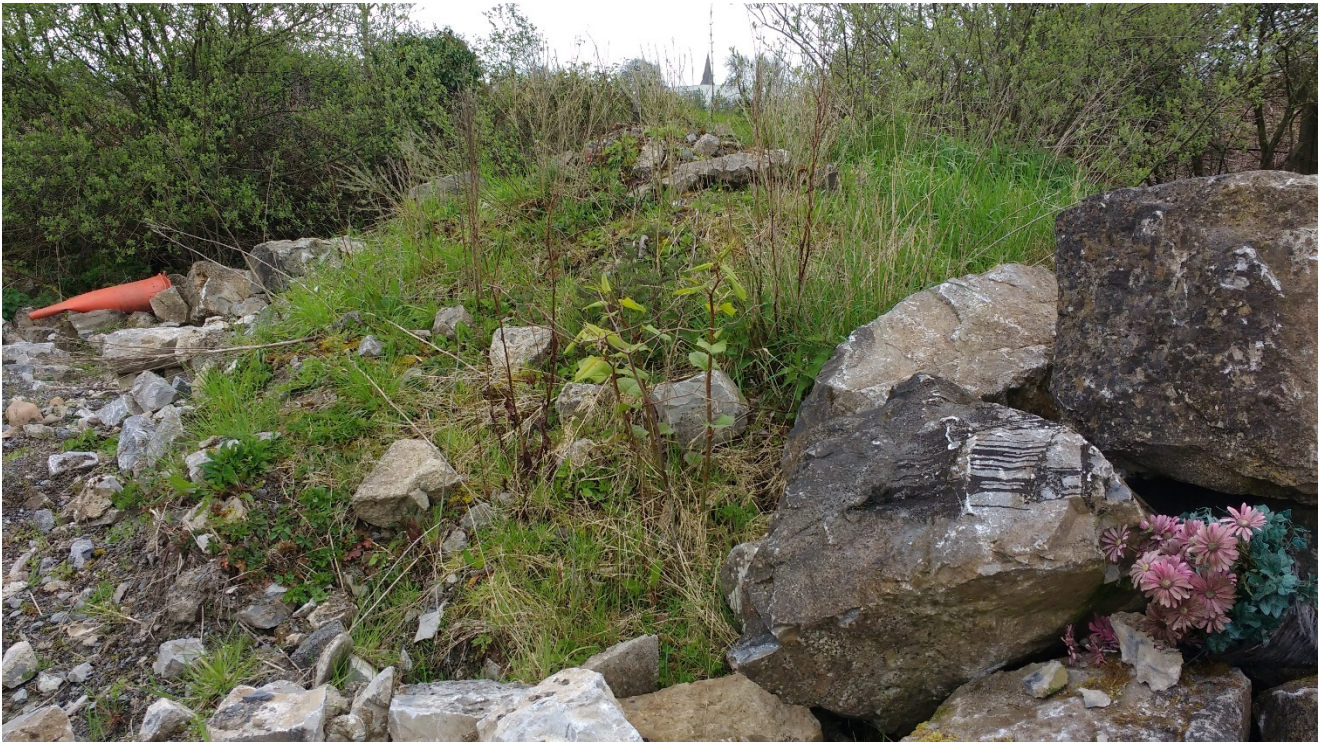
**Plate 16: Japanese Knotweed Area 14, May 2018**

This growth consisted of several small stems when observed during the initial survey on 3<sup>rd</sup> May 2018. The area has since been disturbed by the movement of adjacent soil in the intervening period however, and currently only one stem is visible.

It was not possible to confirm through observation whether or not this had been treated, due to the stem being partially obscured by soil, and the fact that natural die-off may have occurred; IPS have indicated that this growth was treated however.

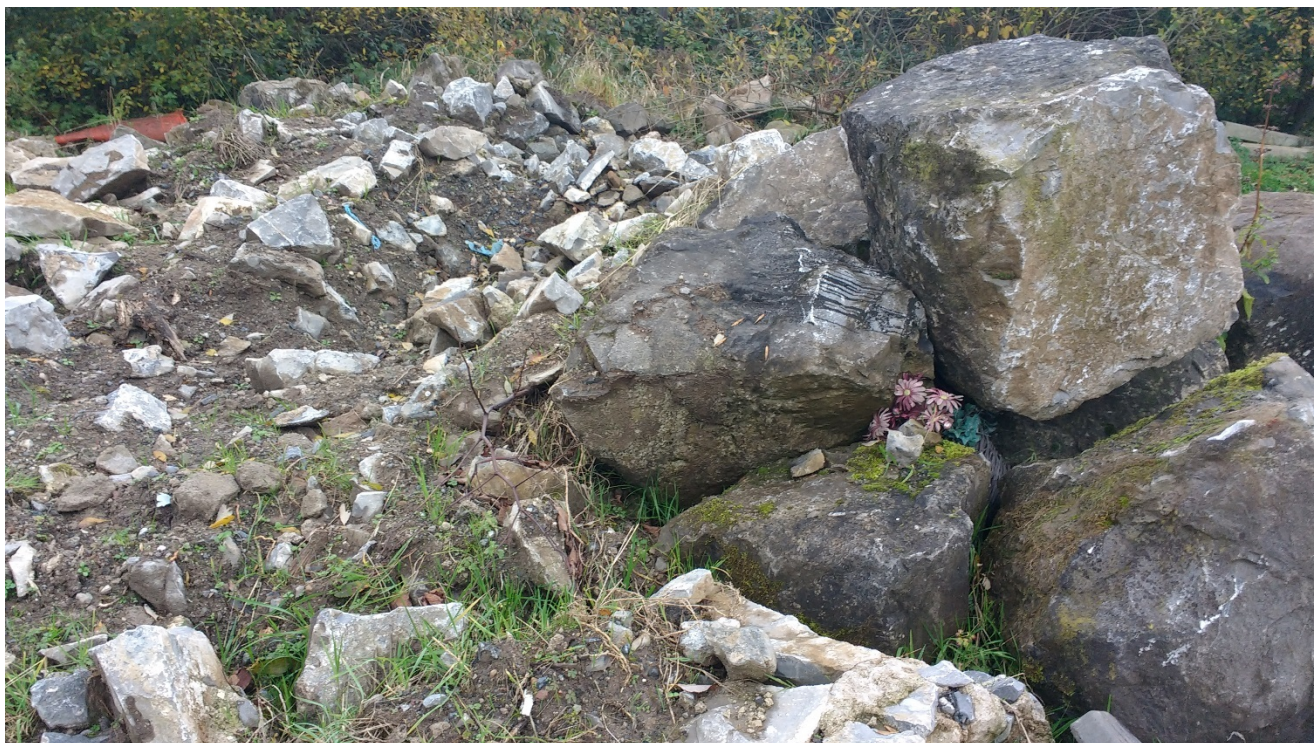
**Plate 17: Japanese Knotweed Area 14, November 2018 – note spoil has been dug out from behind the growth**

The disturbance of spoil near area 14 (see plates 17 & 18) is cause for concern, since this could potentially result in the spread of Japanese Knotweed to other areas and interfere with the treatment programme at the landfill. In this instance interference with the rhizome does not appear to have occurred, but rather the canes were destabilised and partly buried when soil was scraped from the mound behind the growth. It is understood that Tipperary Co Co are taking measures to prevent further disturbance in future.

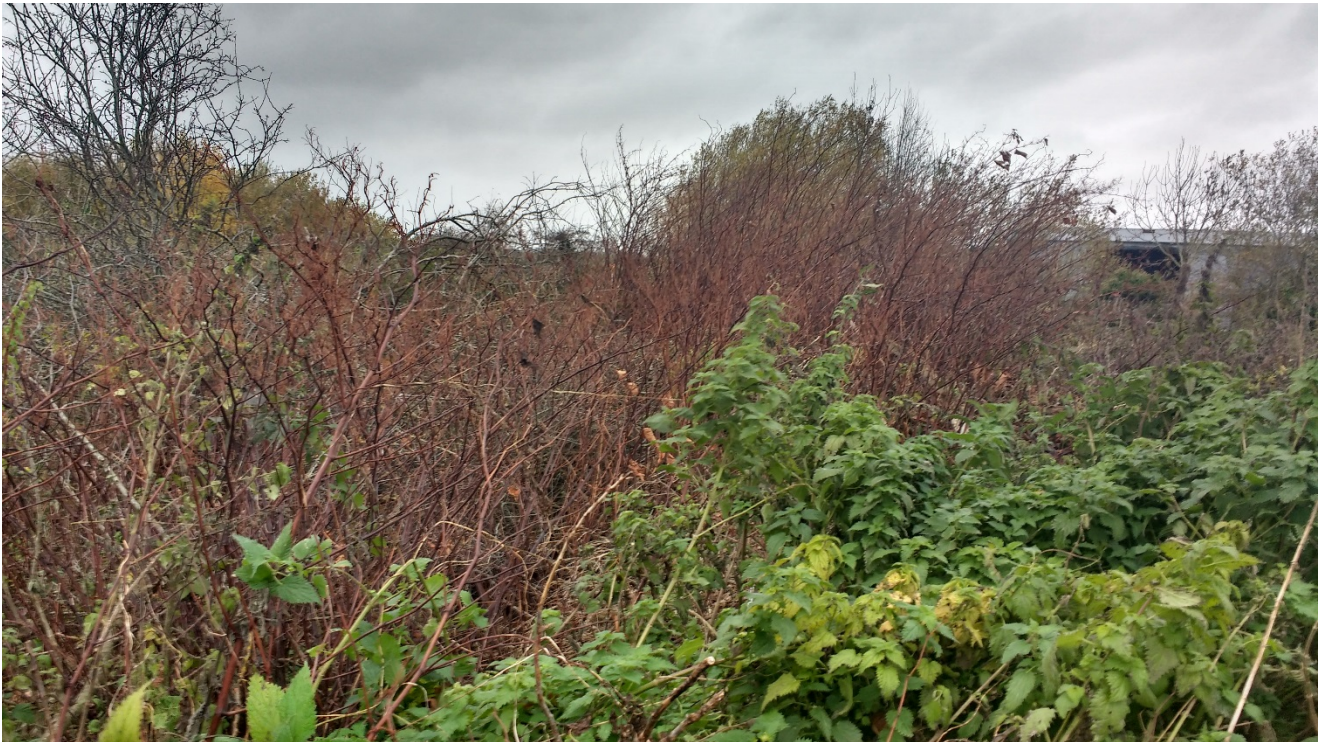
**Plate 18: Japanese Knotweed Area 15**

Area 15 is a large, extremely dense, and well-established growth which starts at the southern edge of the landfill site and extends southwards along a bank, and into an adjacent field.

Most of the canes were brown and had needle marks indicating that treatment was carried out and was largely effective. A small number of canes showed signs of resistance, remaining green; however, this is normal for large vigorous growths and the high percentage treated successfully indicates that the treatment carried out was as effective as possible.

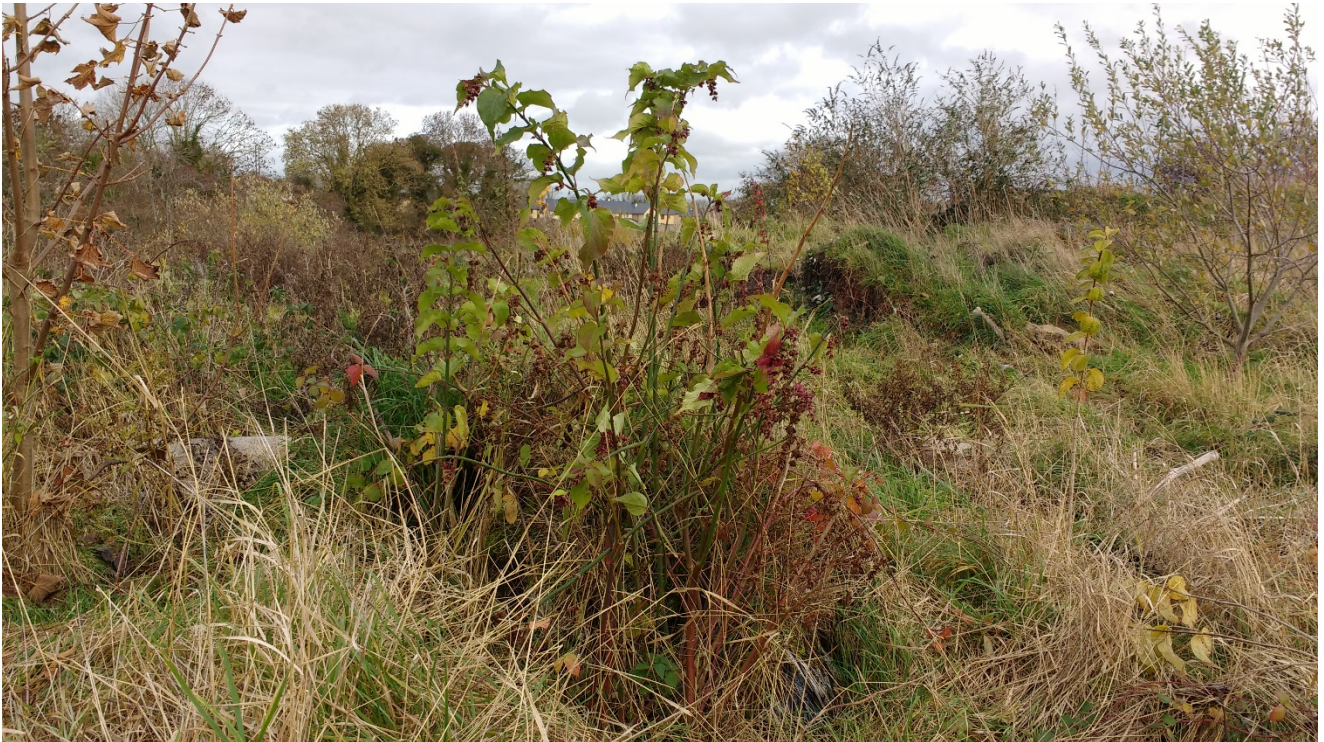
**Plate 19: Himalayan Honeysuckle within the landfill site**

The non-native invasive plant species Himalayan honeysuckle *Leycesteria Formosa* was recorded during the post-treatment survey carried out on 13<sup>th</sup> November 2018. This had not been recorded during the previous survey. The record consists of one multiple-stemmed bush (see Figure 1 and plate 20 below).

This species has not been assessed as posing a *risk* of becoming a medium impact invasive; it's limited extent within the site and susceptibility to herbicide treatment means it can be easily incorporated into the treatment schedule.
