TIPPERARY COUNTY COUNCIL

TEMPLEMORE INFILL WORKS

STAGE 1 ROAD SAFETY AUDIT

Document Control Sheet	
Document Reference	11007 TR01 RSA
Report Status	ISSUE
Report Date	January 2022
Current Revision	D01
Client:	Tipperary County Council
Client Address:	Tipperary County Council Civic Offices Emmet Street, Clonmel Co. Tipperary
Project Number	11007

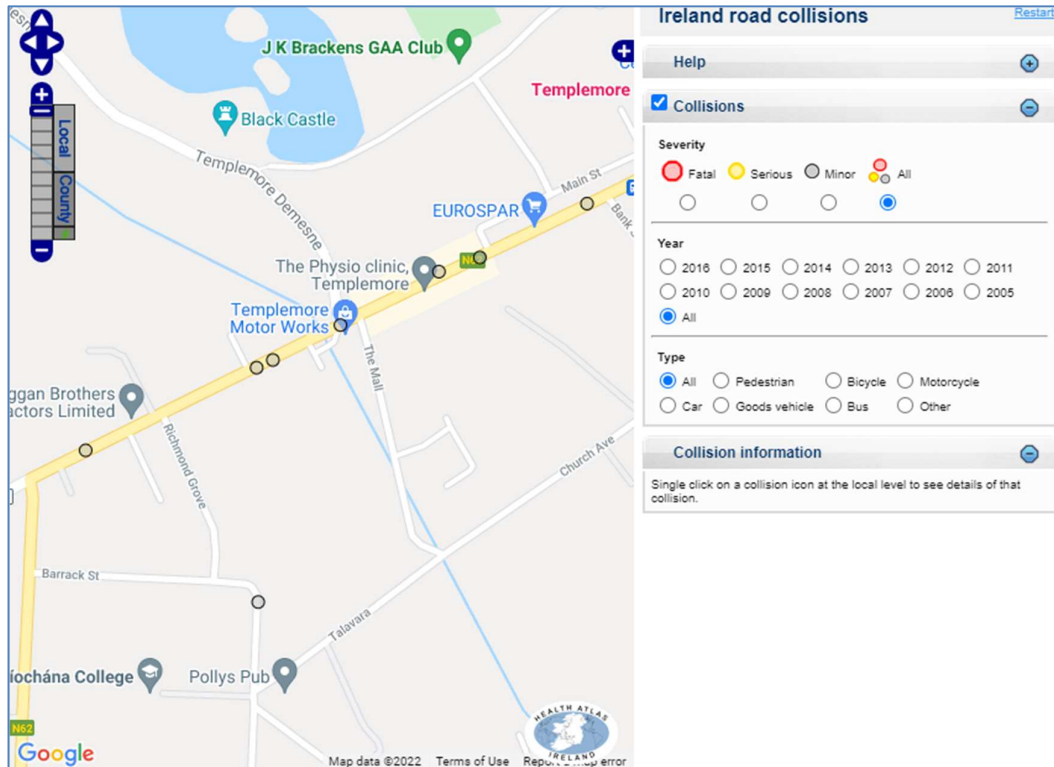
Figure 1-3 Road Collision Data 2005 – 2016 (Source: Road Safety Authority)

Road Collision Data available on the Road Safety Authority Database, within the period 2005 to 2016, along the section of proposed scheme identified 1 no. minor (single vehicle) collision recorded in 2013 as shown in Figure 1-3.

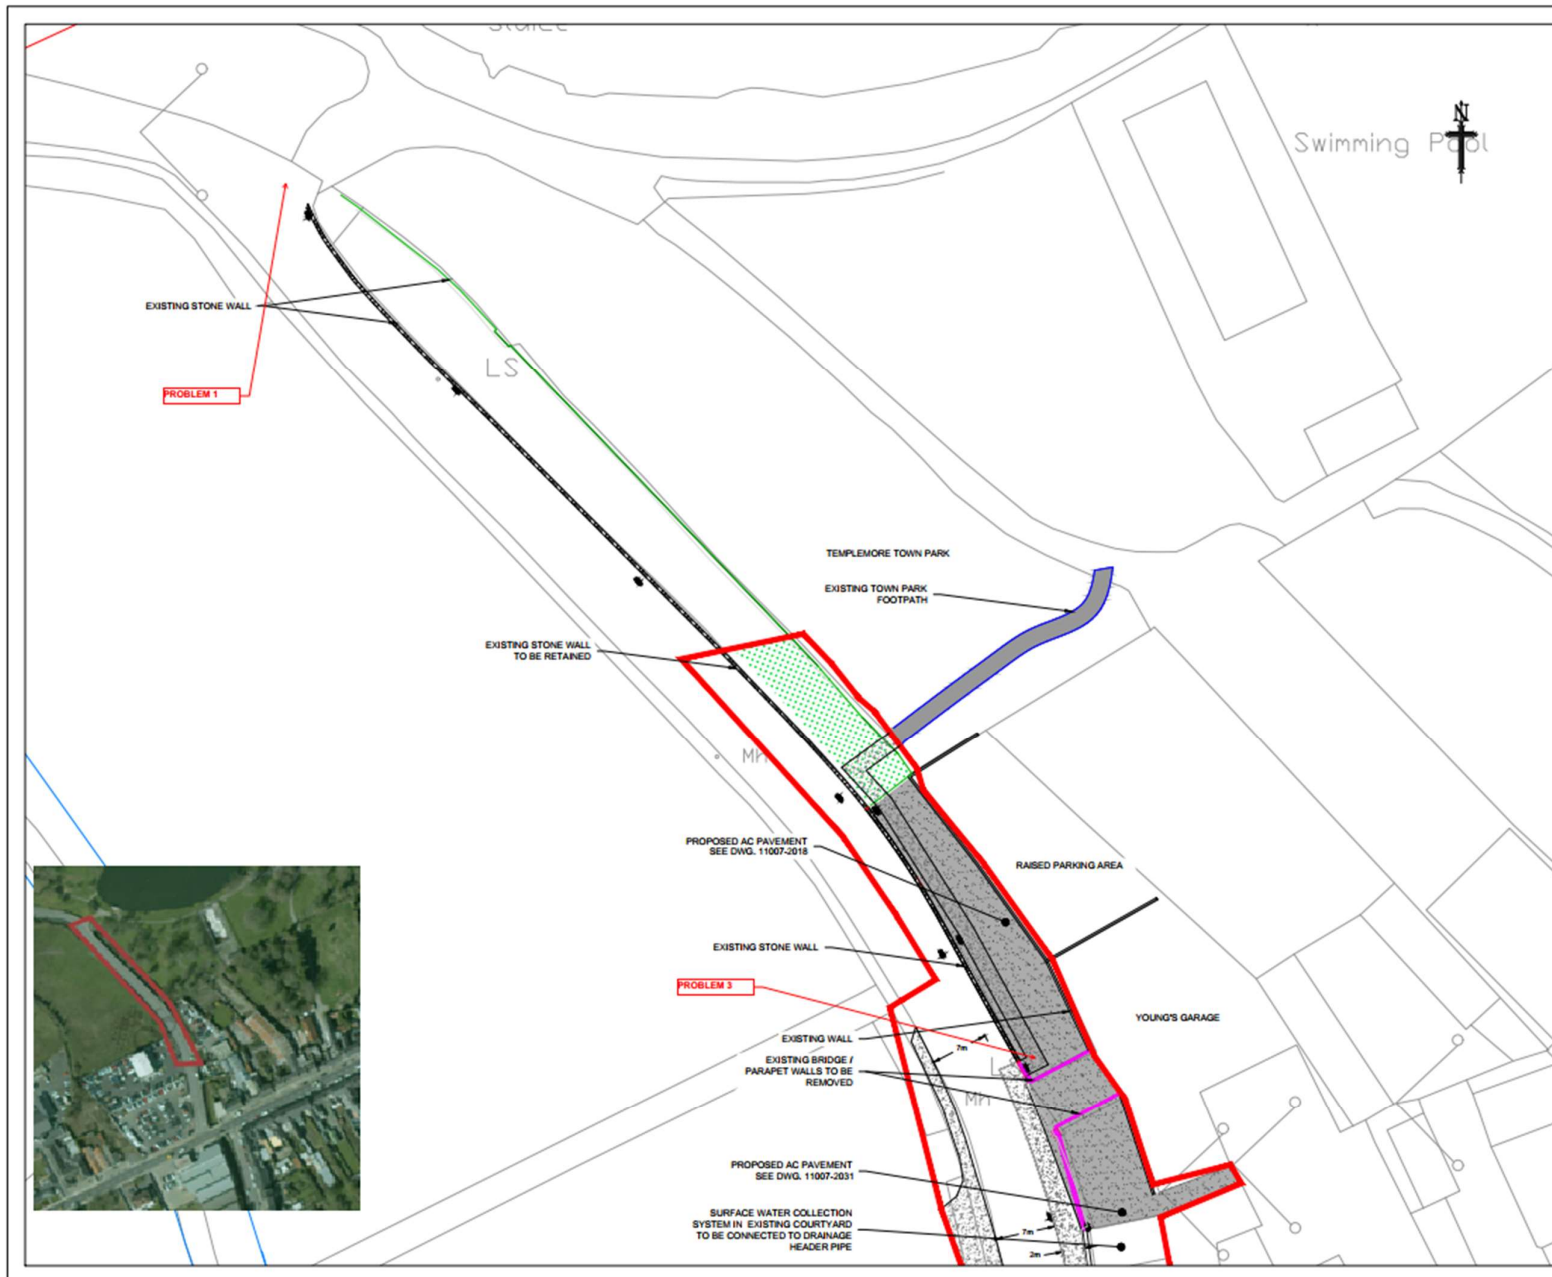
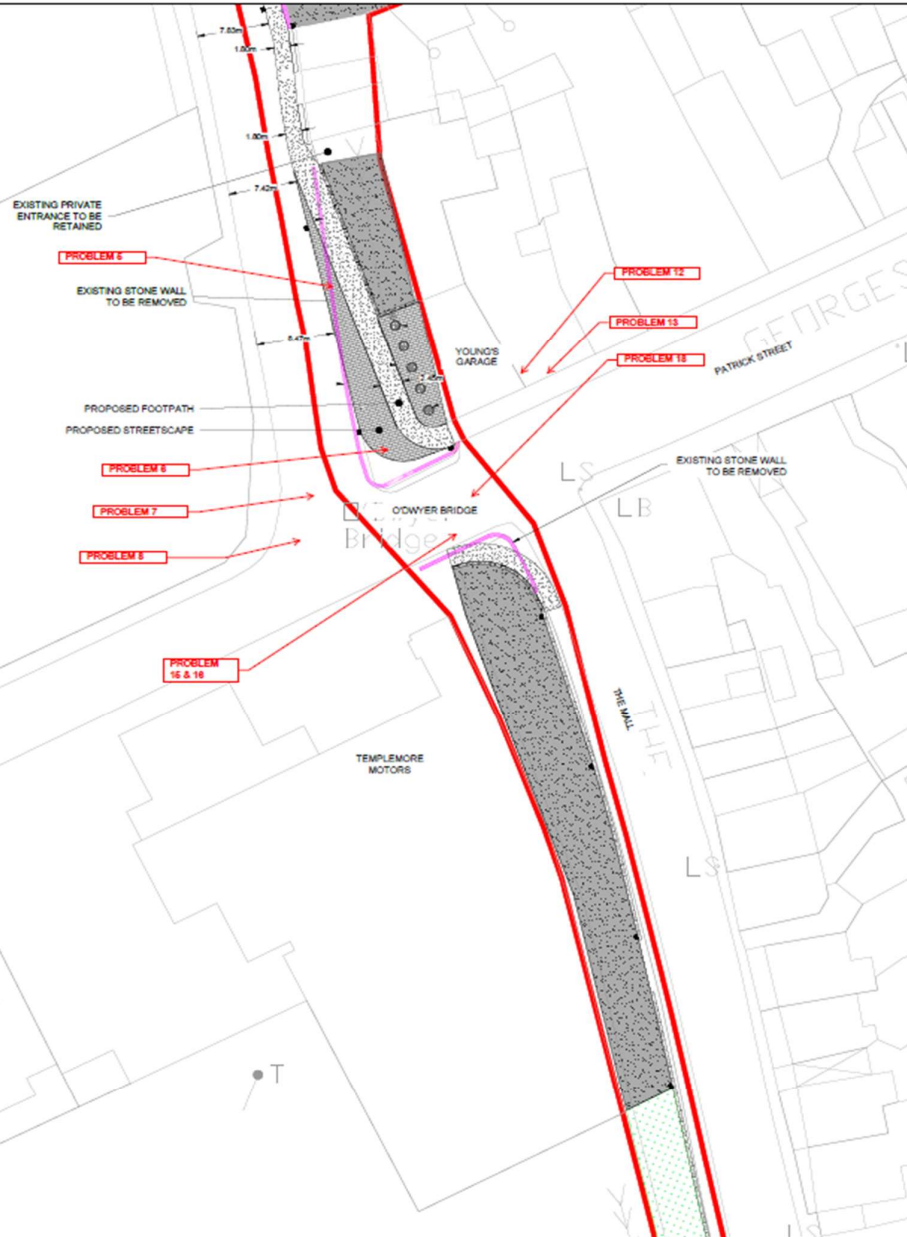
Appendix C – Problem Map

GENERAL PROBLEMS APPLICABLE THROUGHOUT THE SCHEME:

- PROBLEM 4
- PROBLEM 9
- PROBLEM 10
- PROBLEM 11
- PROBLEM 17
