**General Conservation Notes** A. All drawings to be read in conjunction with the Conservation Architect's current versions of Conservation Reports in 3 Volumes: Vol 1 – Conservation Report – Architectural Inventory and Appraisal

## Schedule of Works

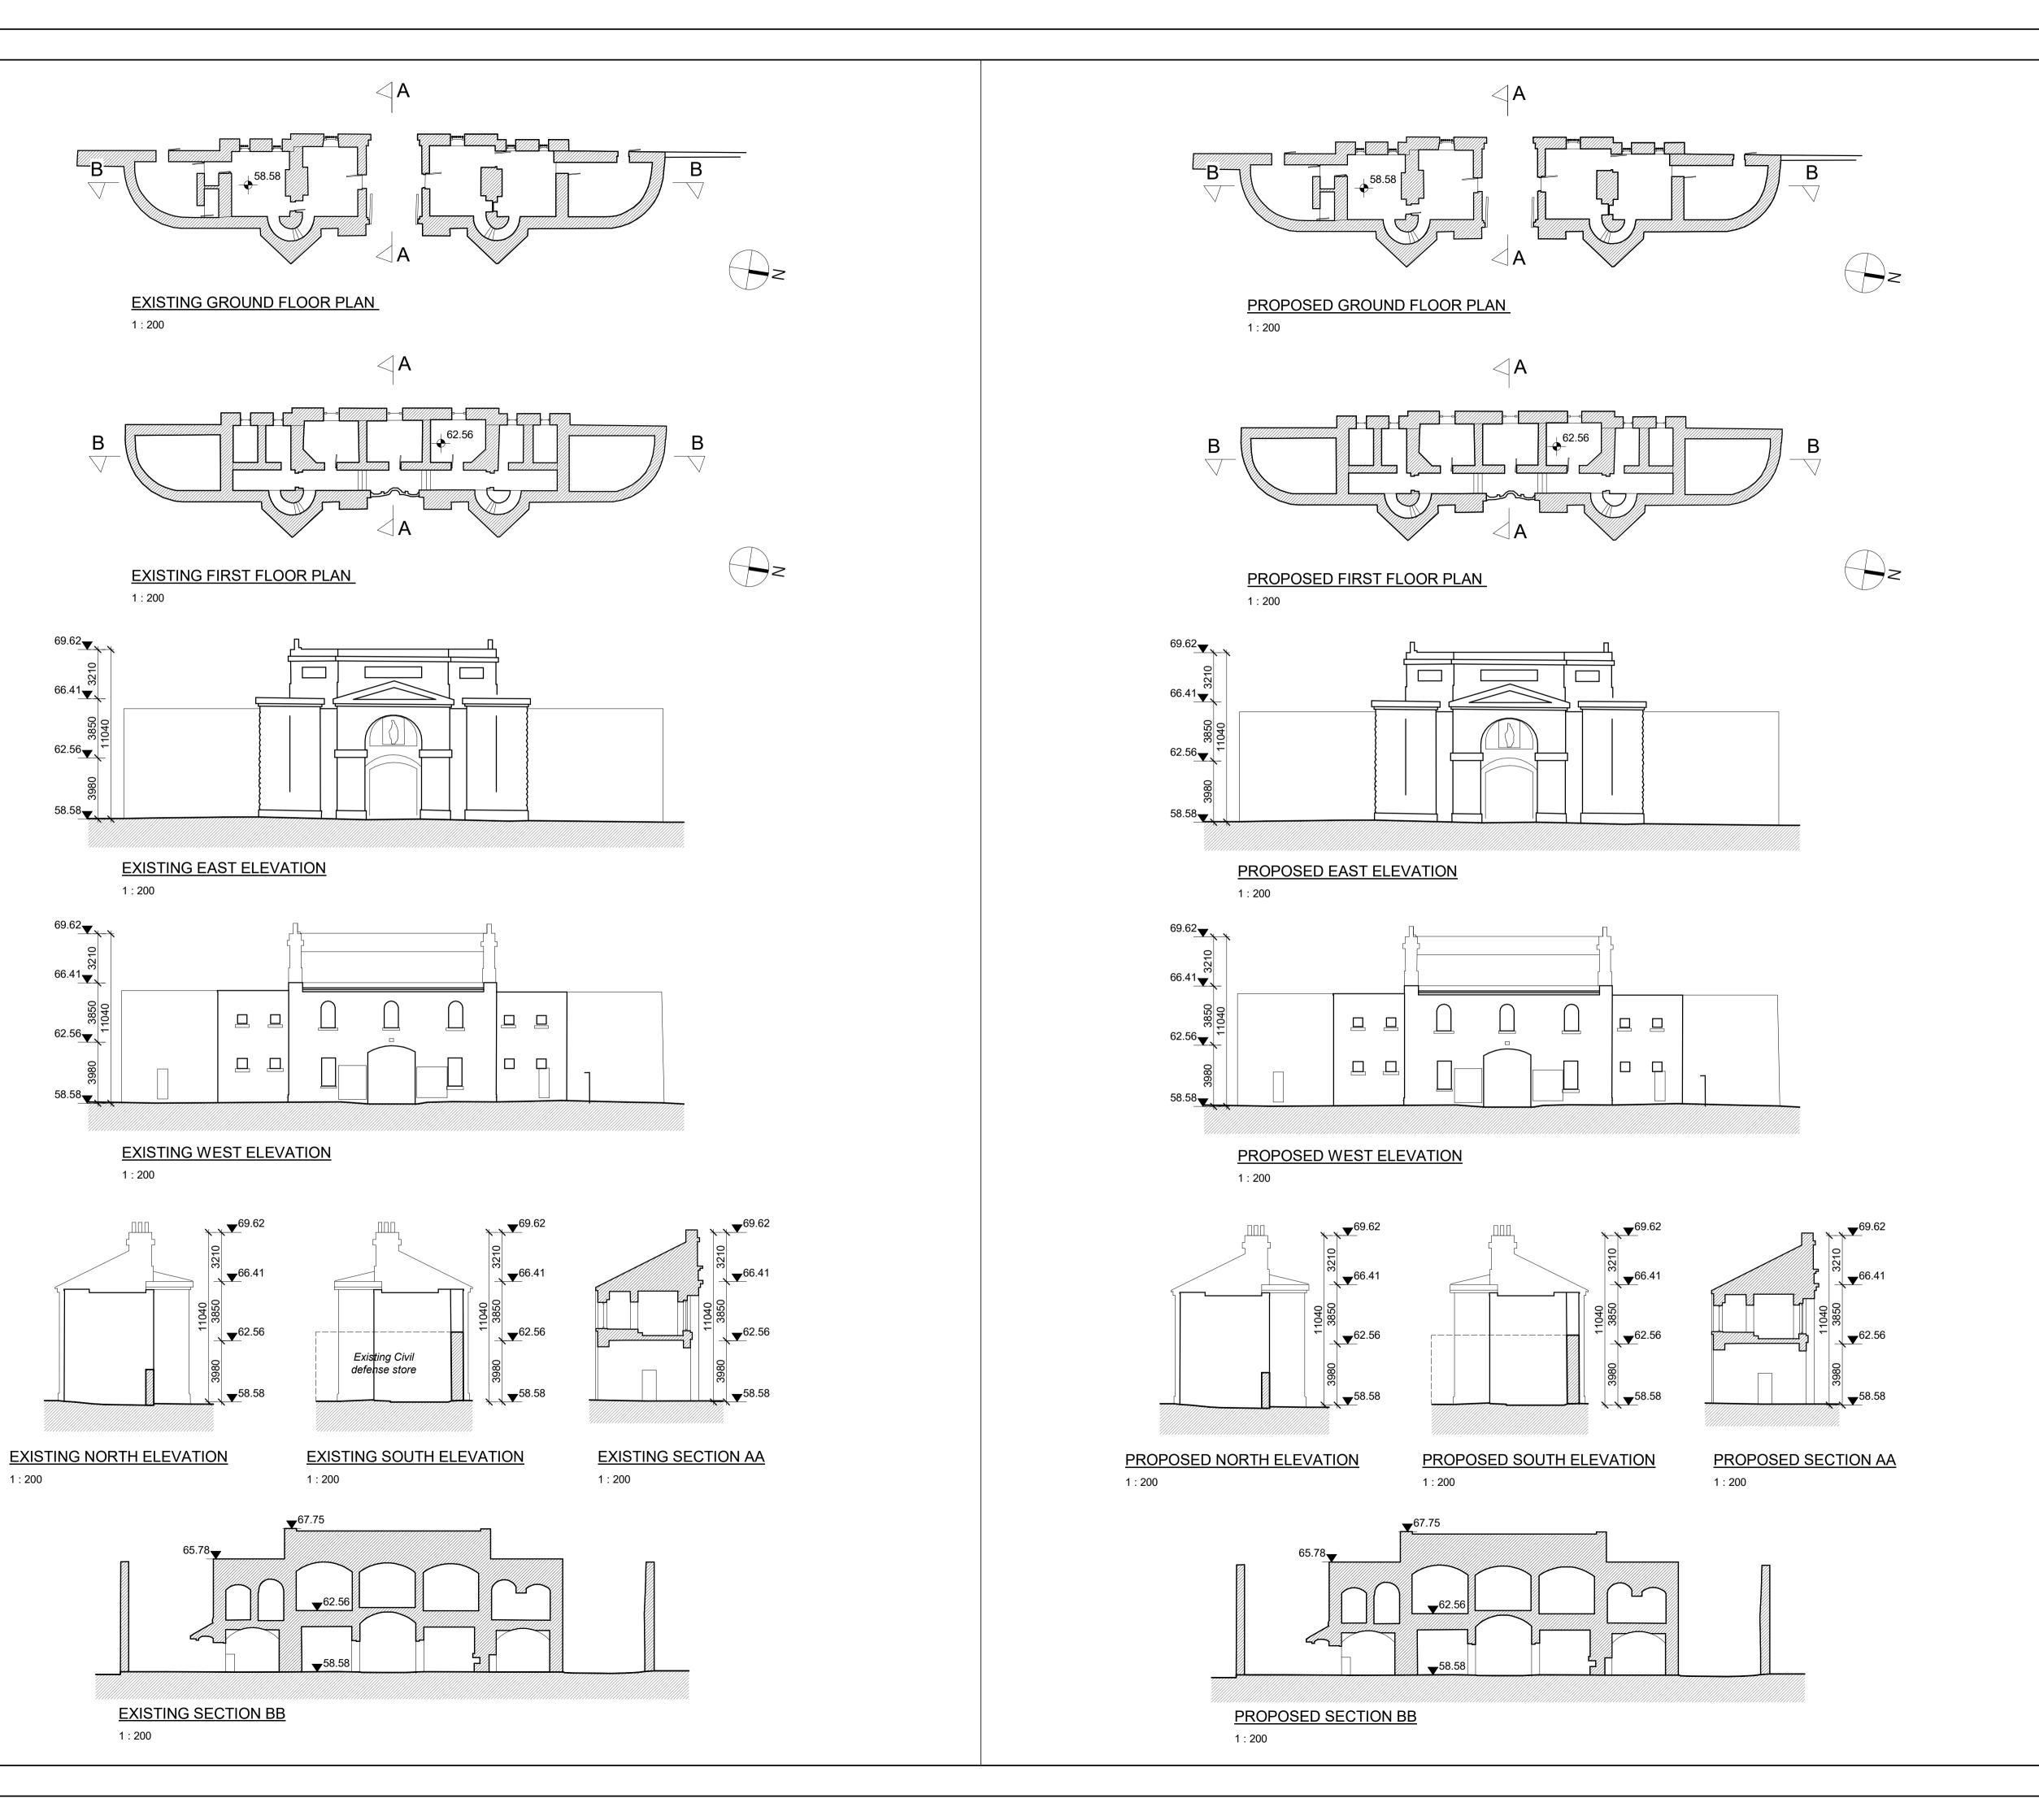
Removal of all vegetation and organic growth to rainwater goods, barges, copings, parapet, and roofs. Investigate barge capping which appears to be failing. Allow for full replacement on both sides with lime-based flaunching.

Localised repairs to slate roof to replace broken or slipped slates using natural slate to match in composition and size. Allow for partial re-bedding and clamping of parapet wall stones and new lead

using lime mortar. Replace all flashings on roof complete using lead.

Localised repair of timber roof structure is anticipated - requires inspection to confirm extent of damage from water ingress.
